# Marshalls

## Chartered Surveyors

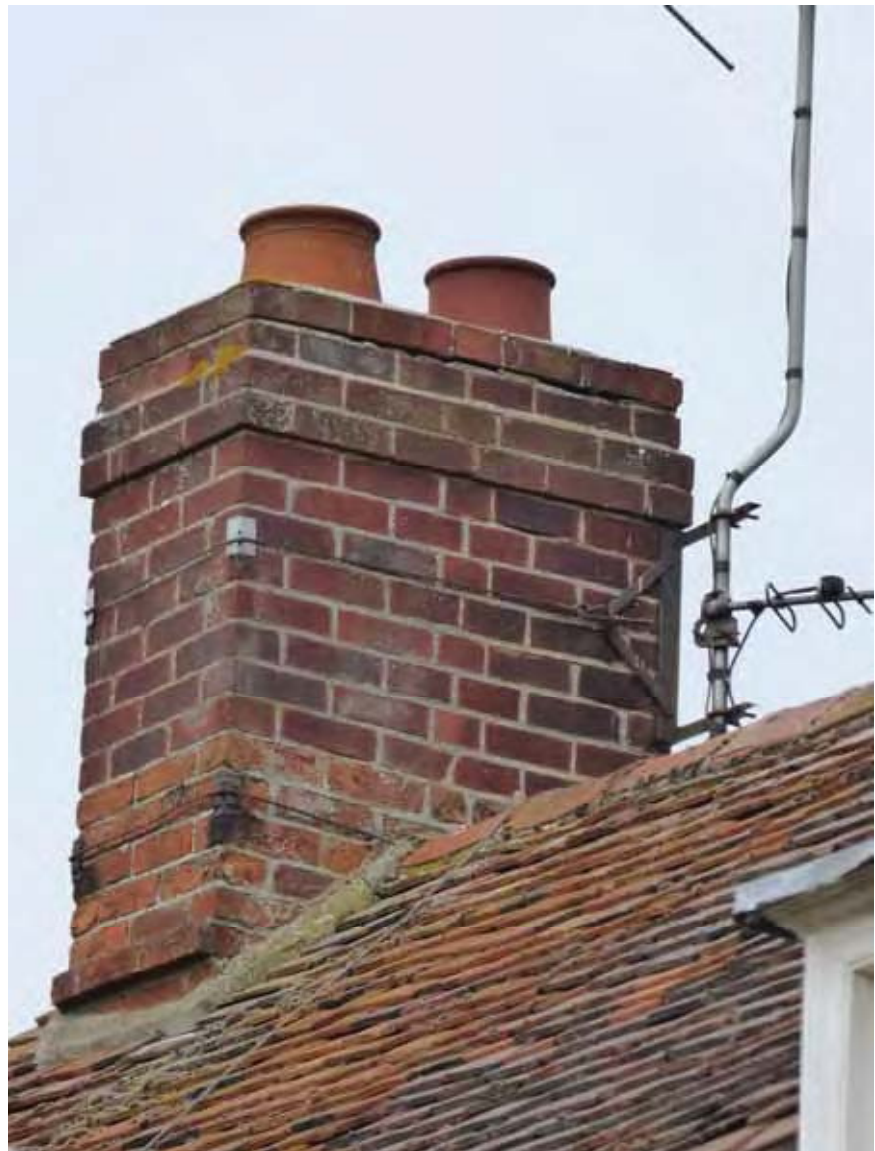
The left side stack, which serves the ground floor sitting room and would have served a fireplace in the bedroom above.

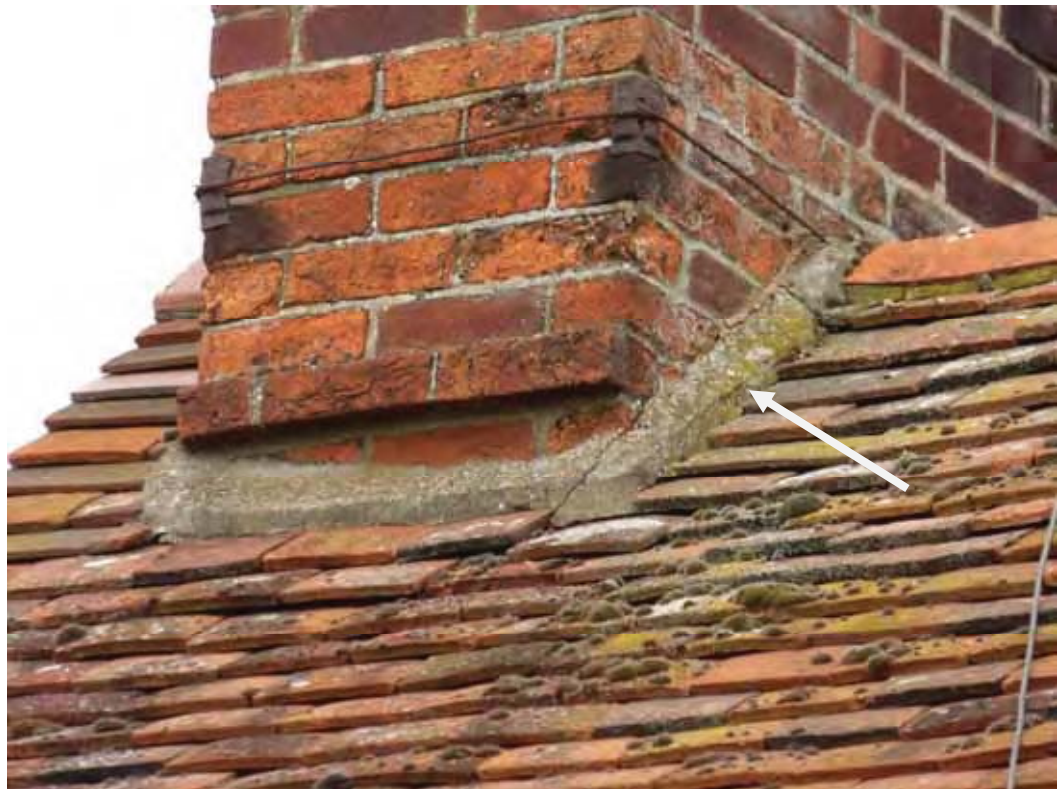
Close view of the mortar fillets – note the cracking and short-term patching with mastic sealer.

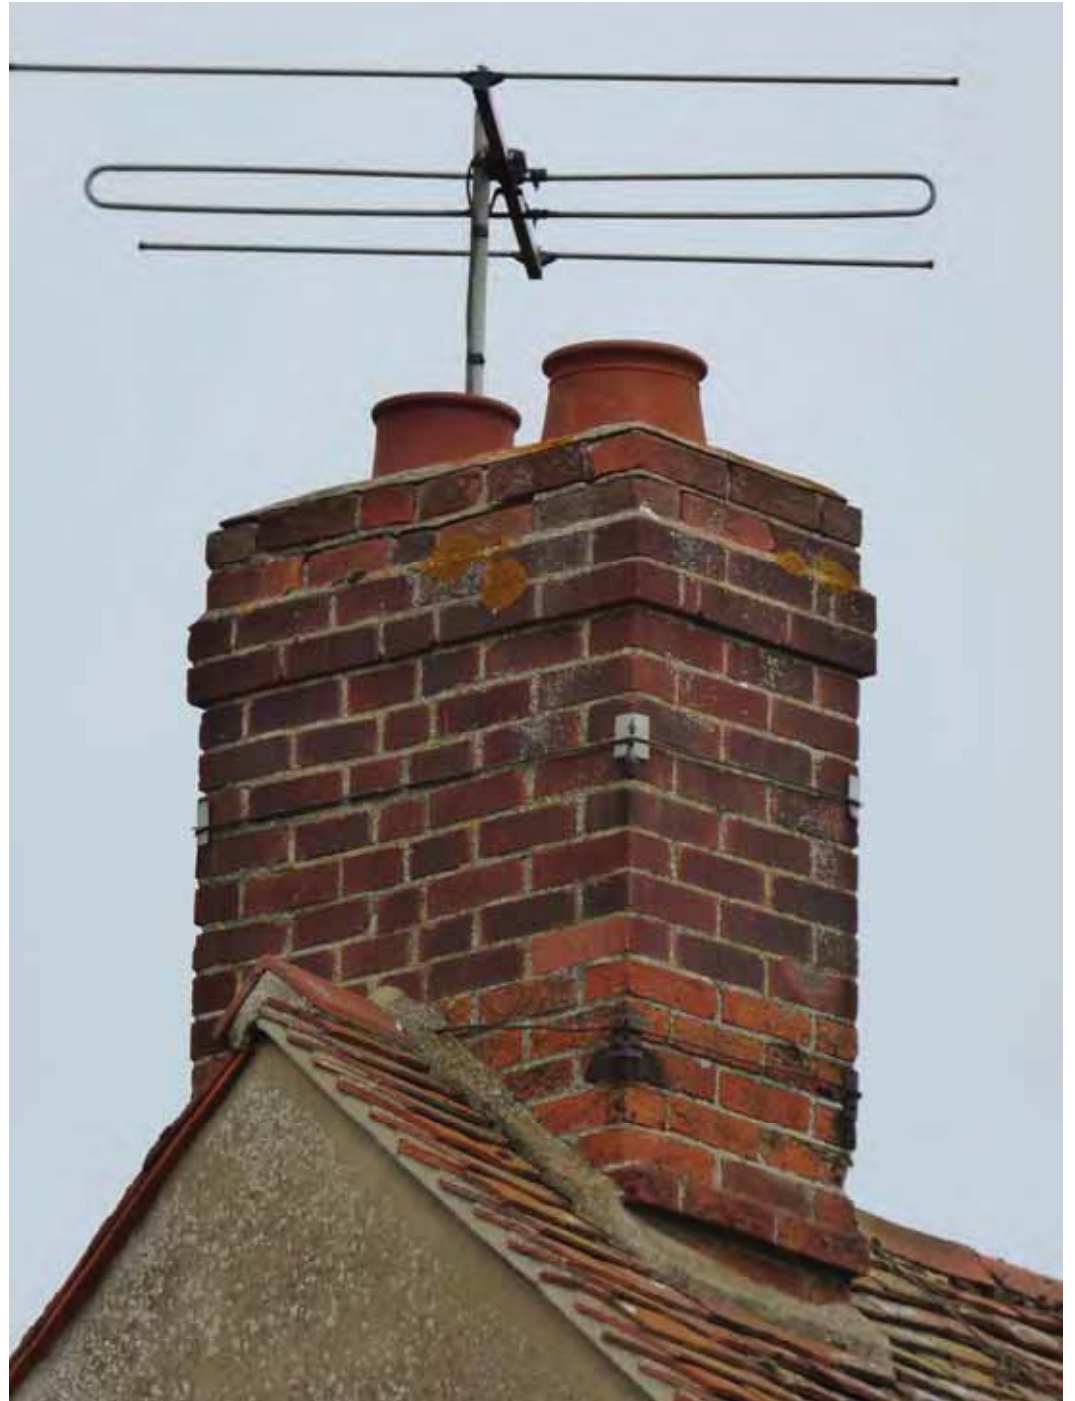
The left side view. It would be best to cowl the unused bedroom flue. Ideally permission should have been obtained for the fitting of the television aerial.

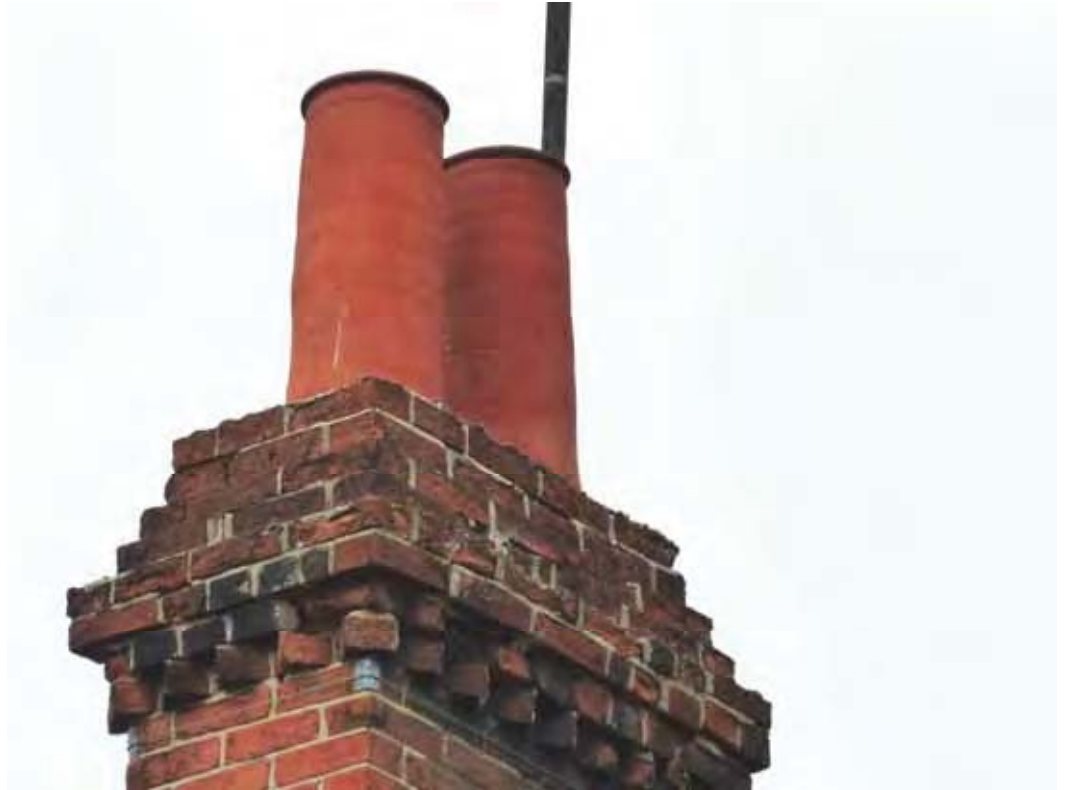
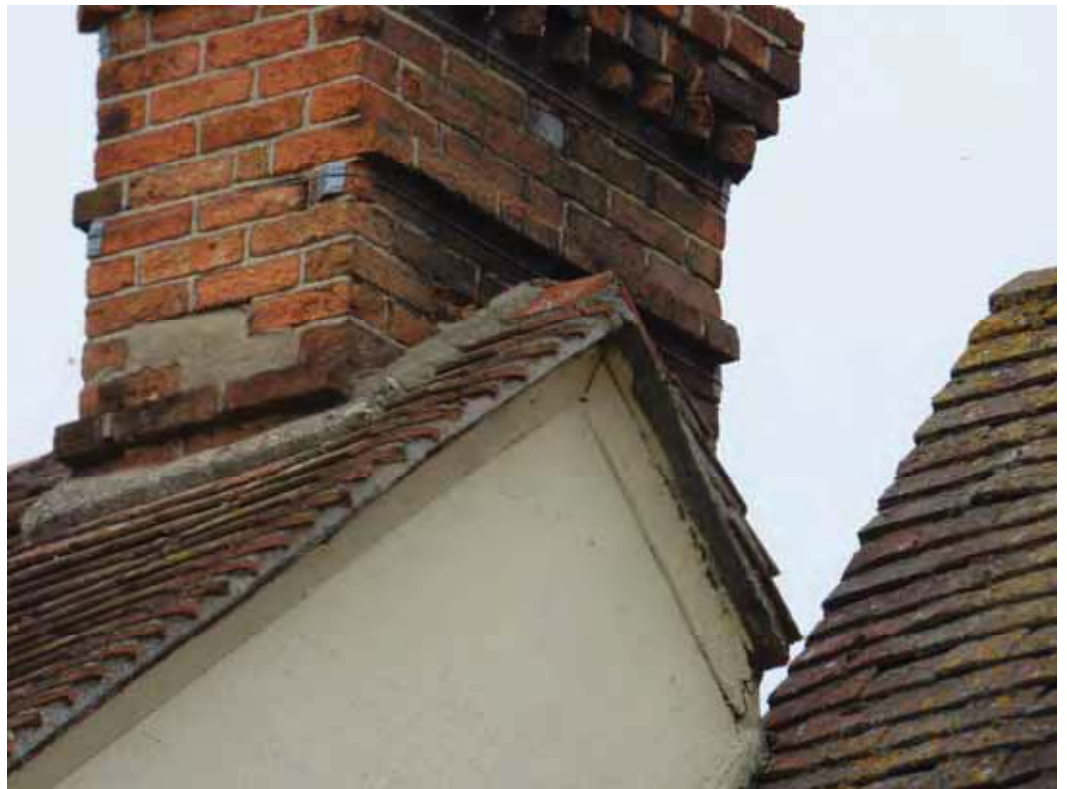
Close views. Note the basic patching to the frost damaged brickwork.

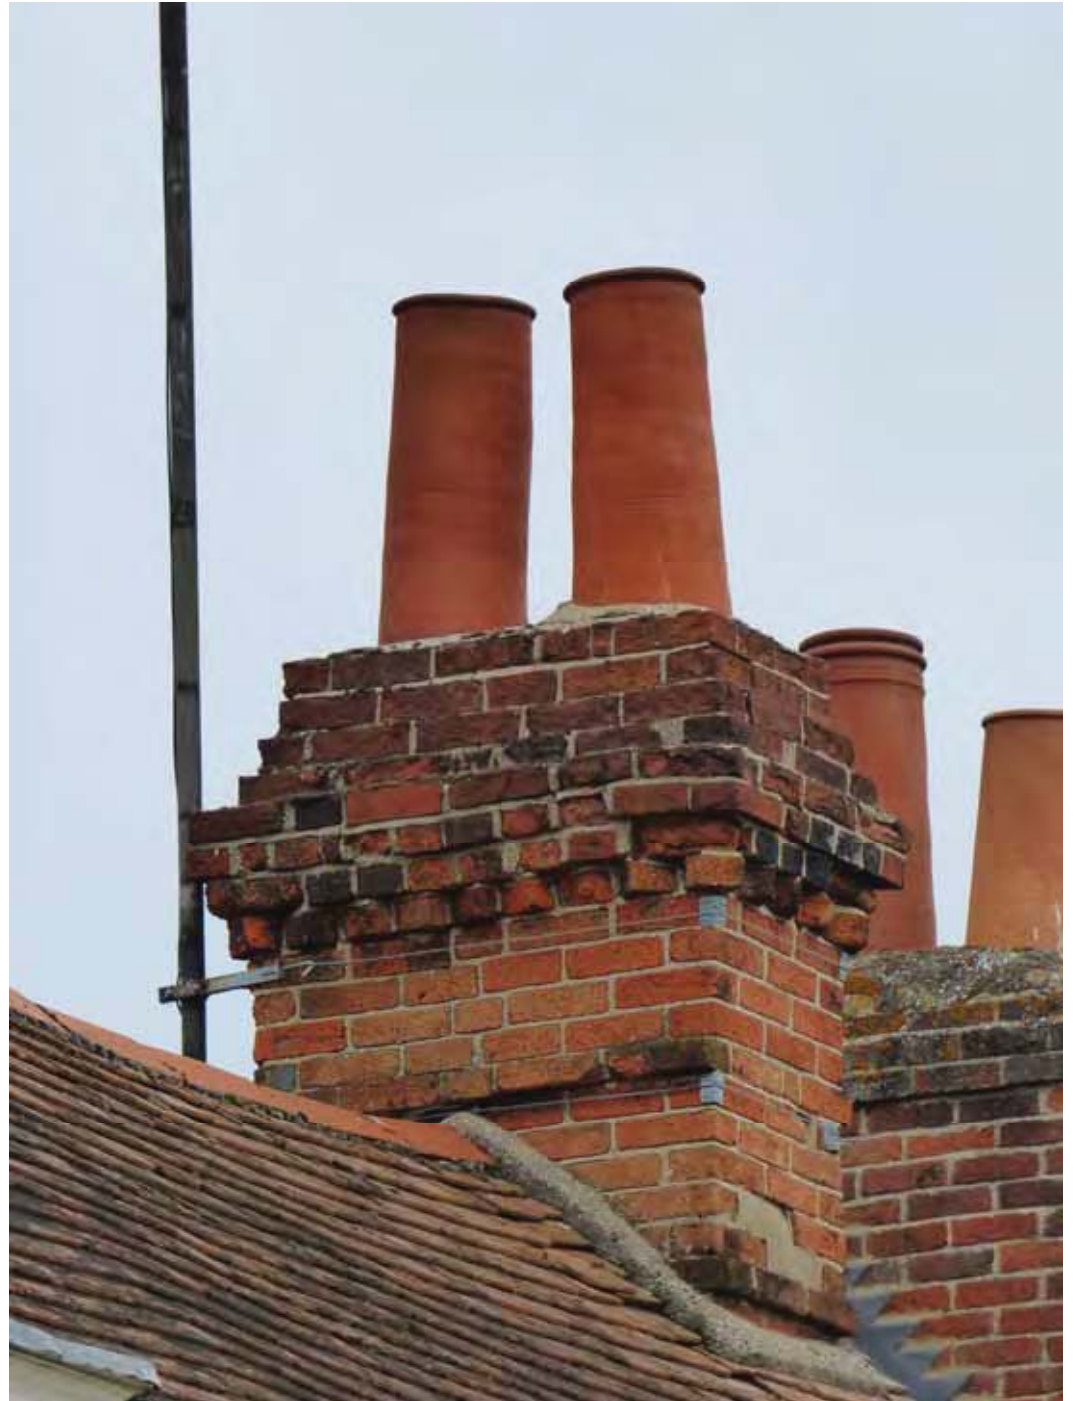
The front left side view – note the pots are out of true and there is cracking visible to the bedding mortar. There is a risk of falling masonry and they should be checked and re-bedded, as necessary. The mortar fillets are in better condition.

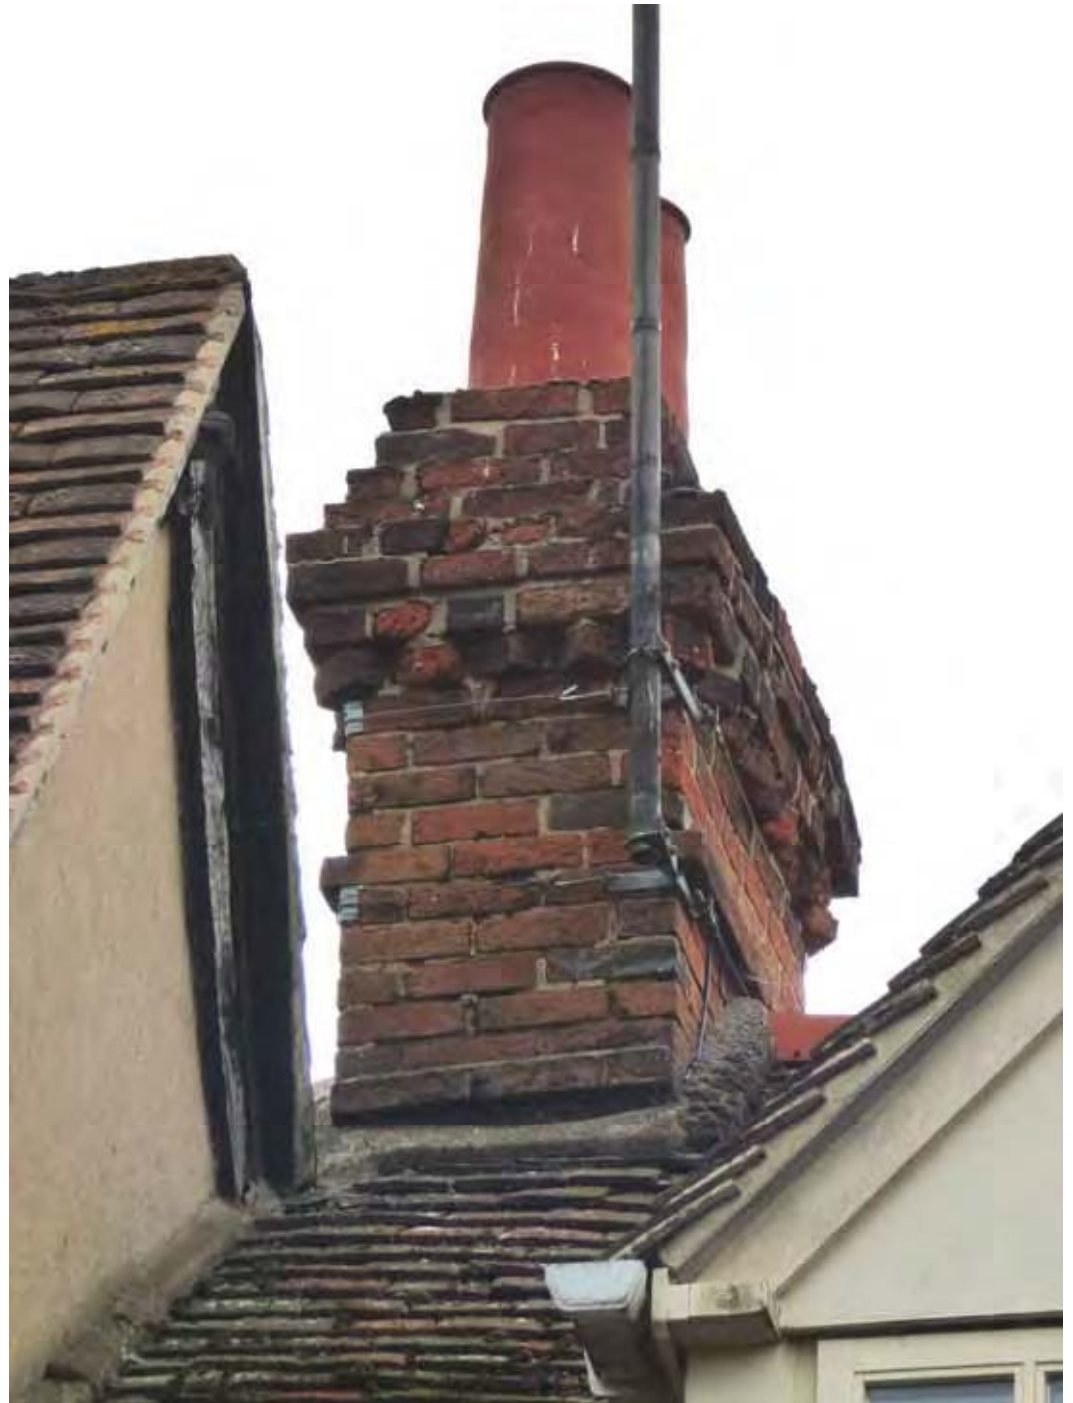
The rear view – note the bulging to the upper courses.

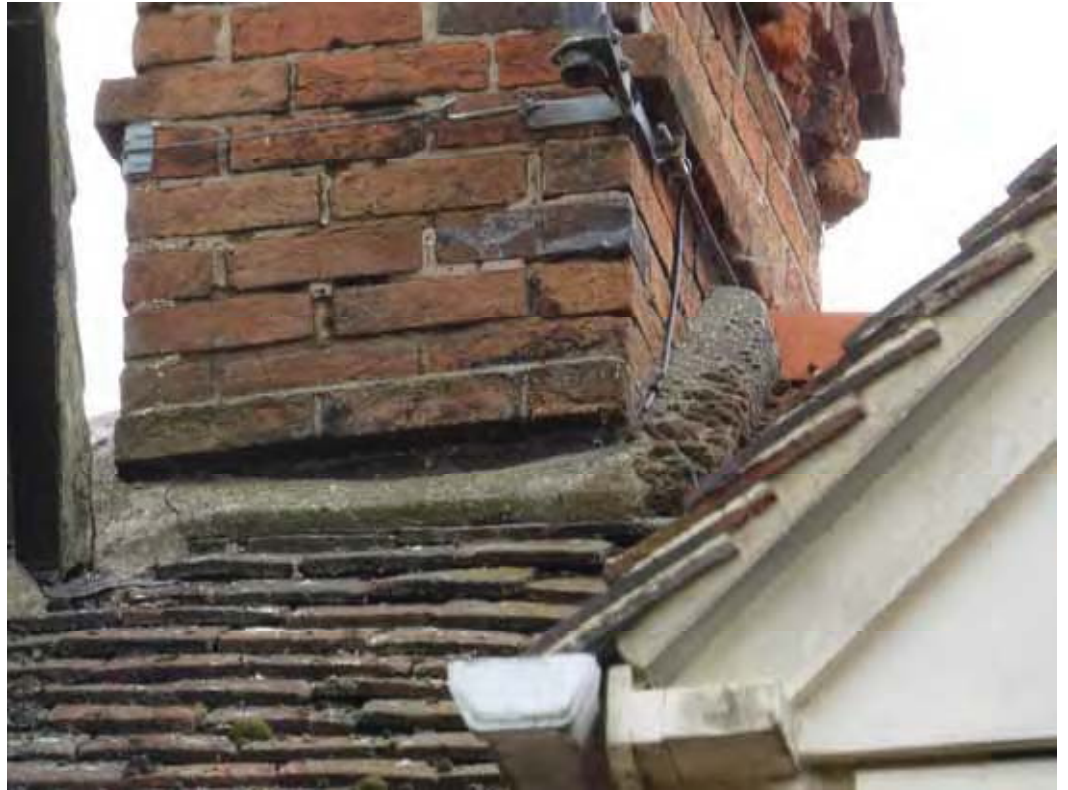
The fillet is slightly cracked.

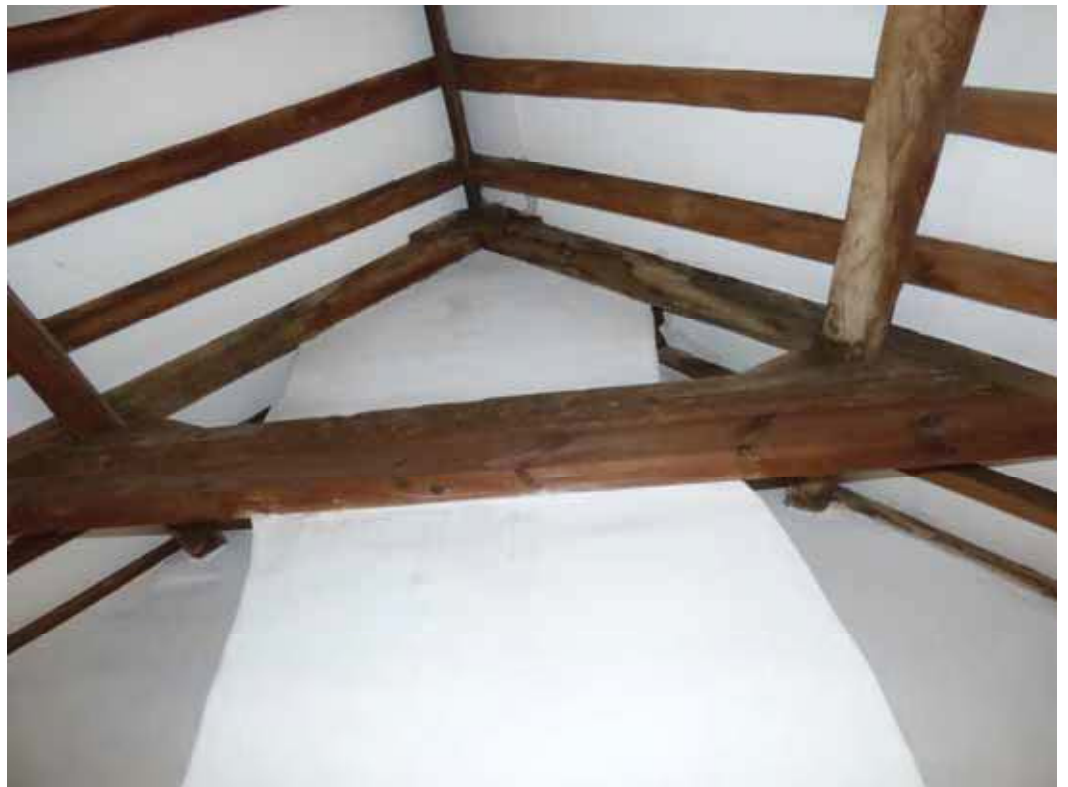
Internal view of the chimney breast.

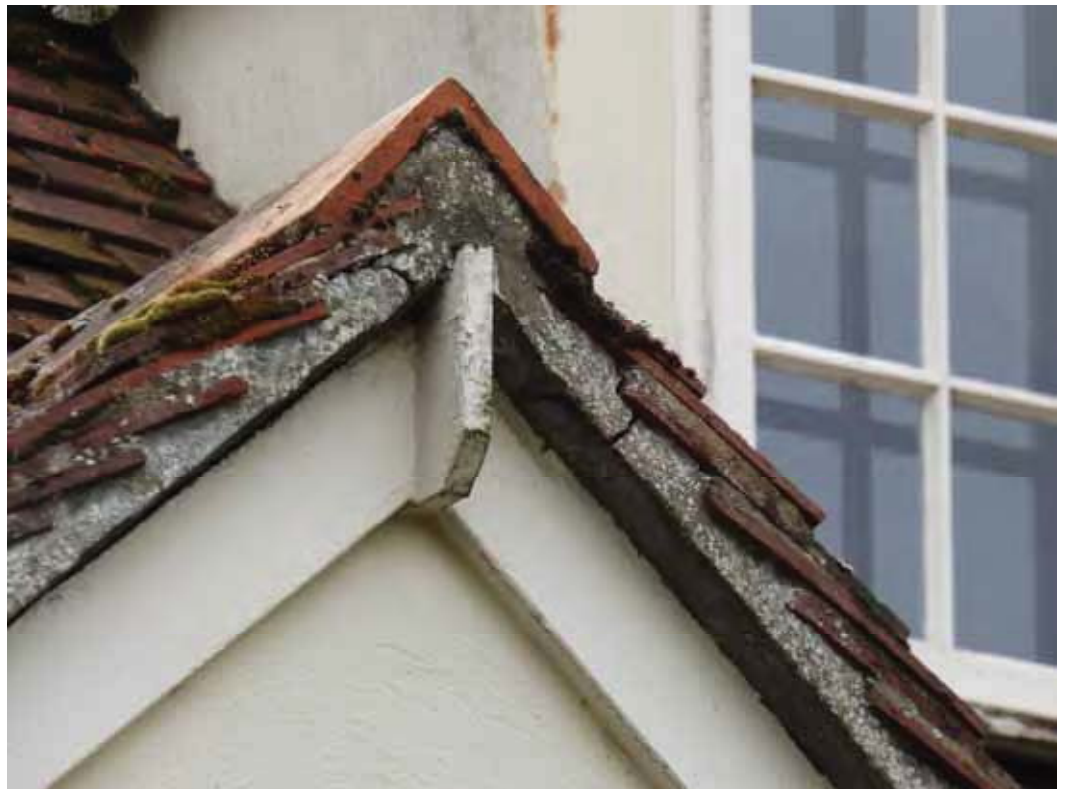
The mortar to the verges has cracked and weathered. Occasional patch pointing will be needed.

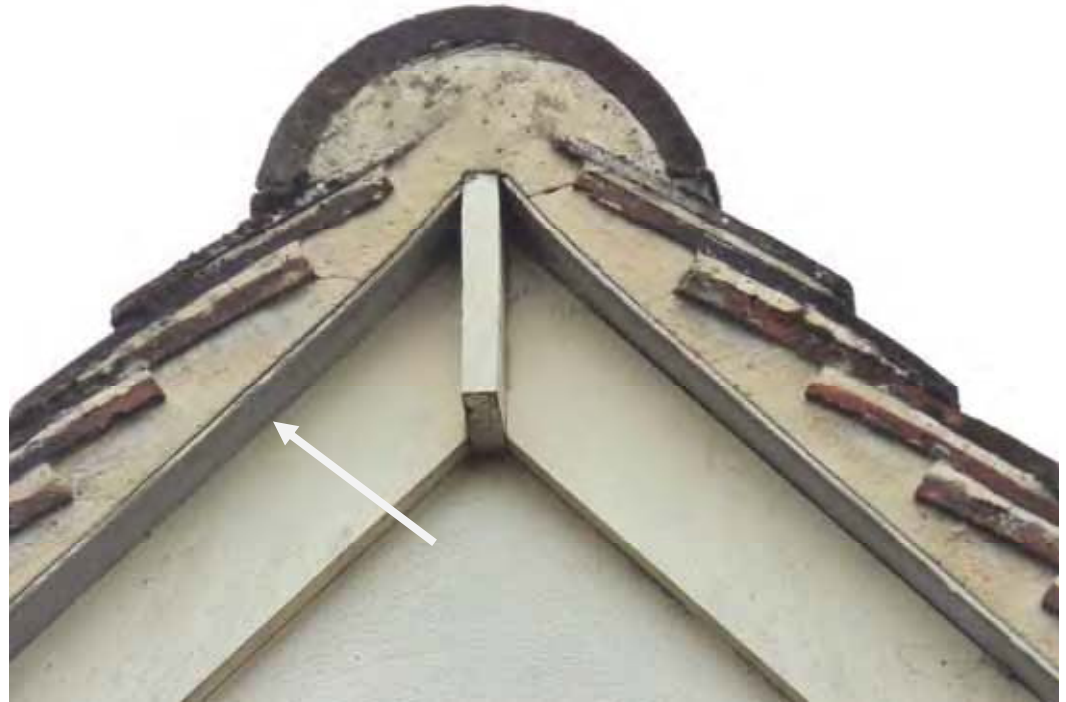
The cement undercloak boards may contain a small proportion of asbestos and appropriate care should be taken.

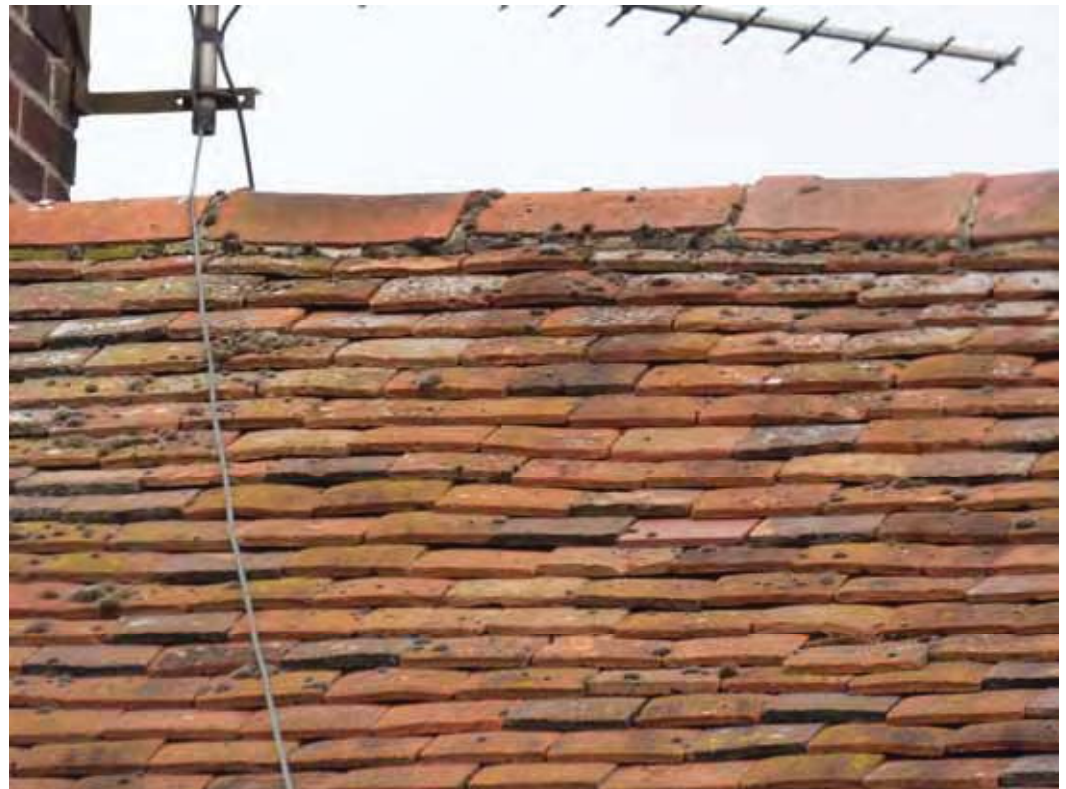
The ridge tiles are satisfactory, although the mortar bedding the tiles has cracked and weathered in areas. Occasional re-bedding may be needed.

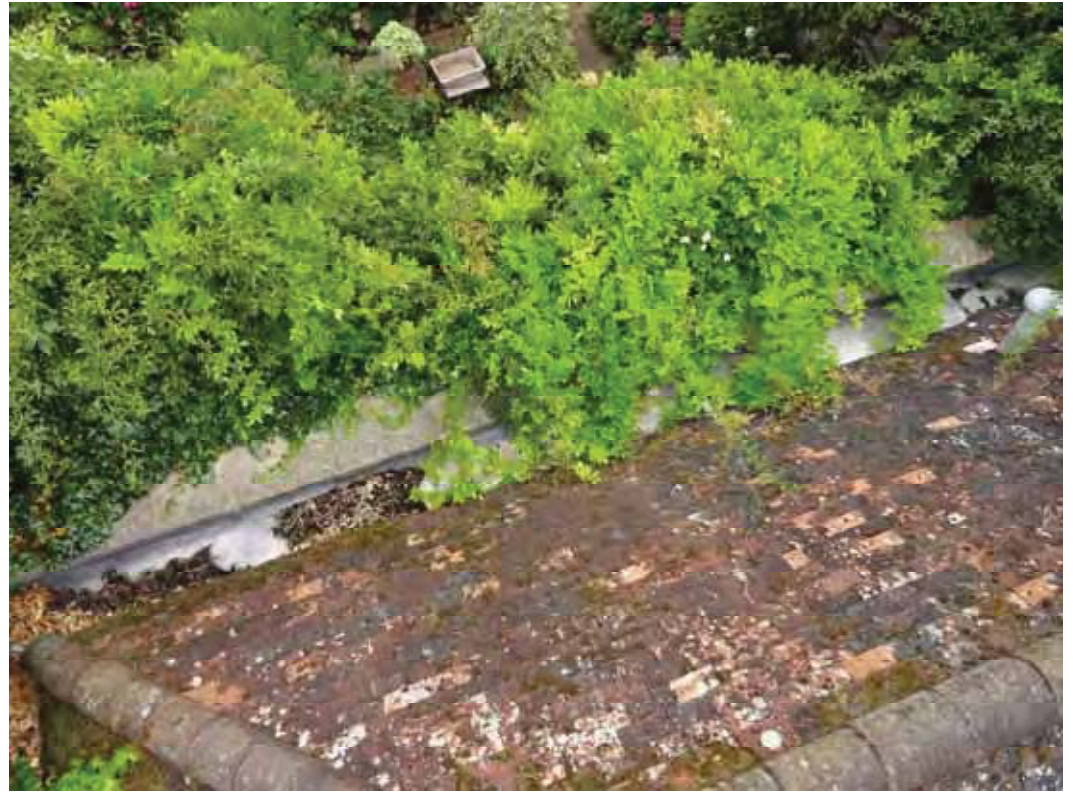
Raised view showing the right side slope and valley gutter. Note the frost damaged tiles.

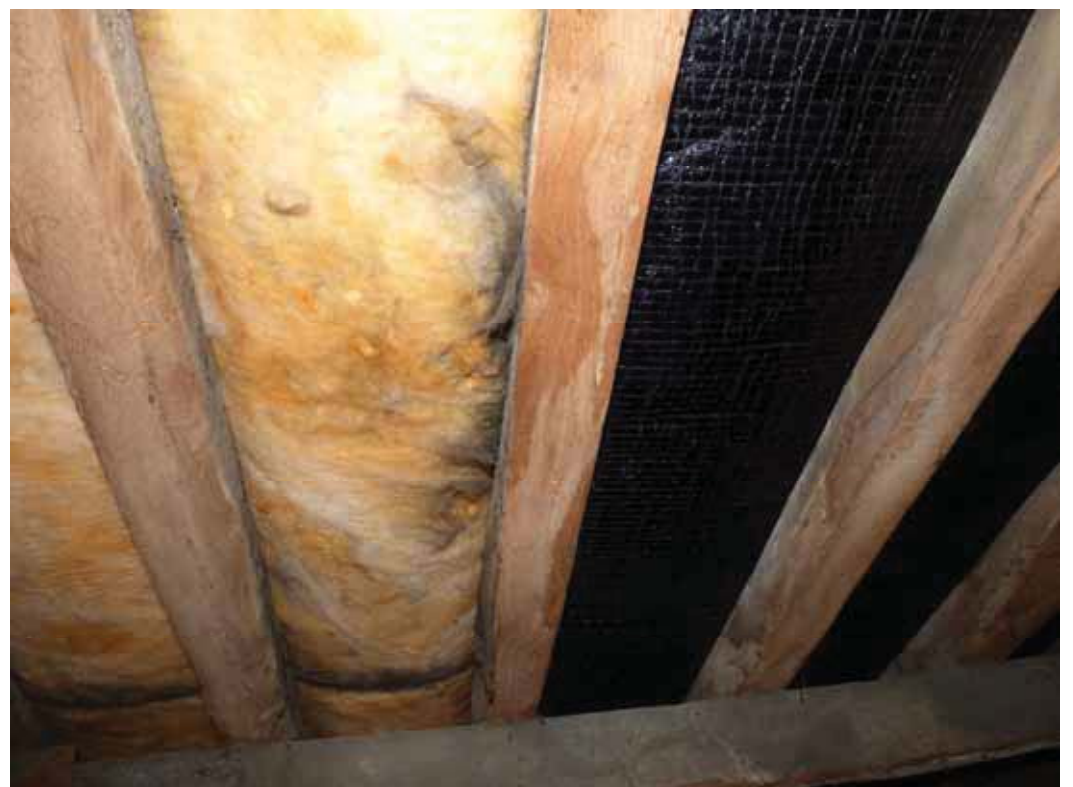
The roof slopes are lined with felt.

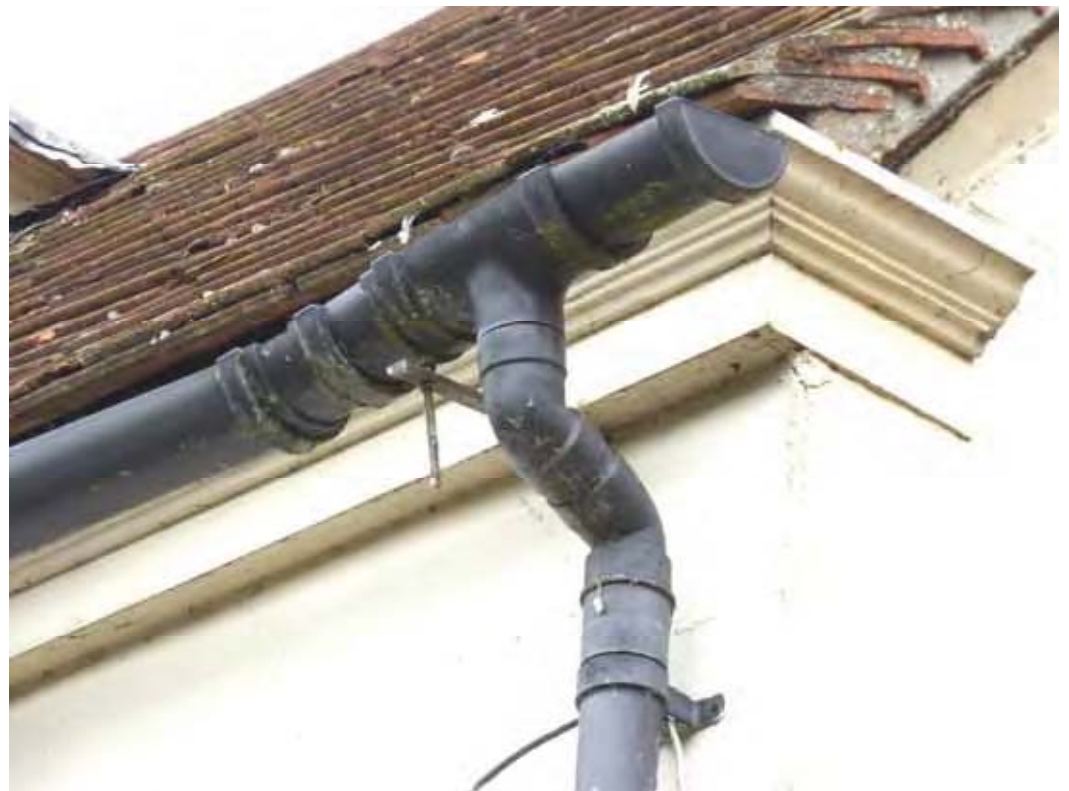
The front right side stop end is out of alignment.

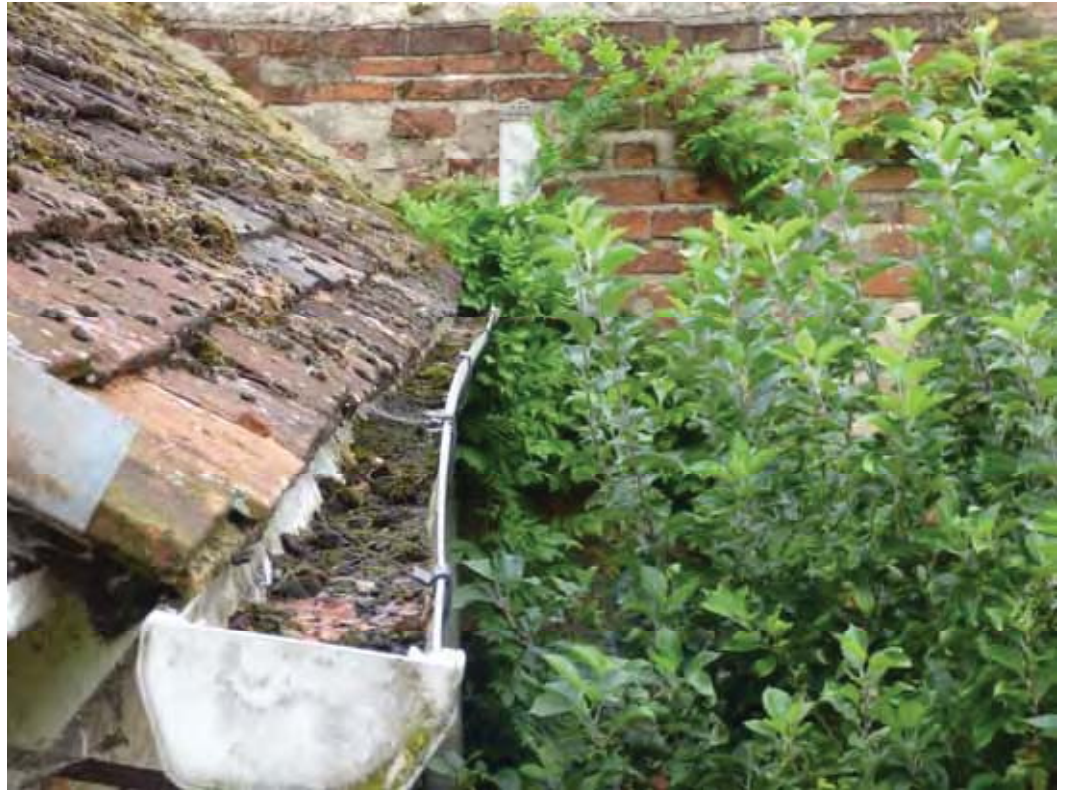
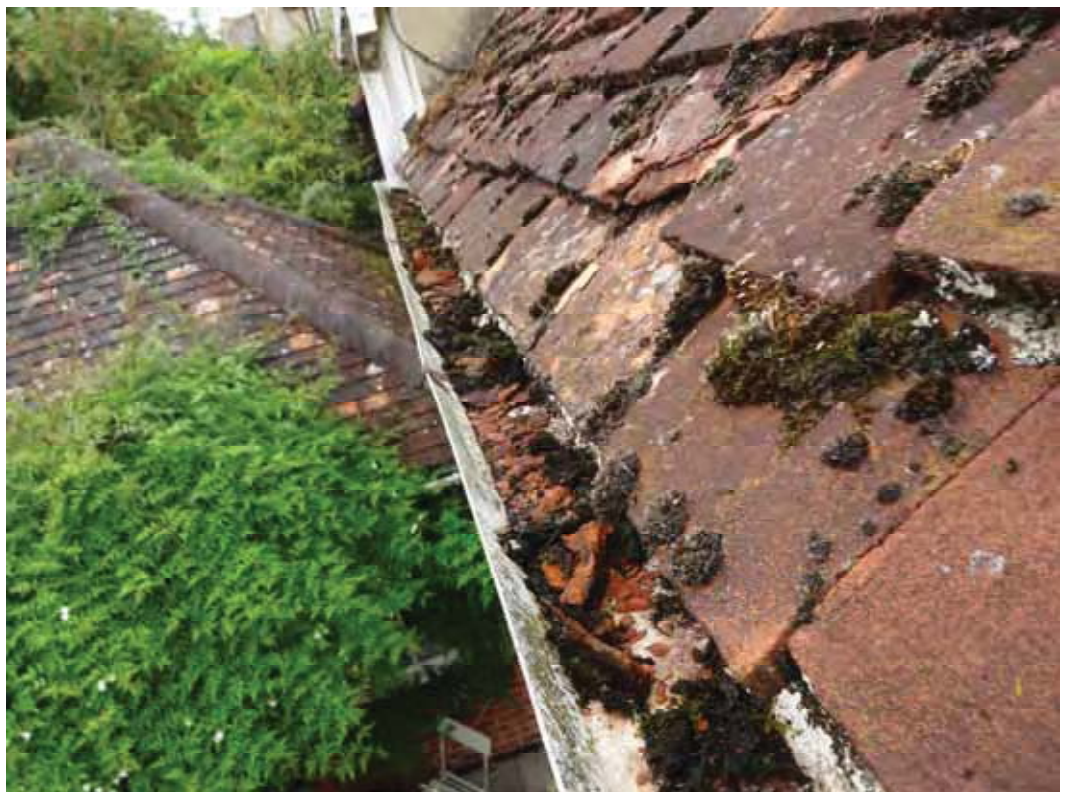
Regular cleaning will be needed due to moss, creepers and the frost damage to the tiles.

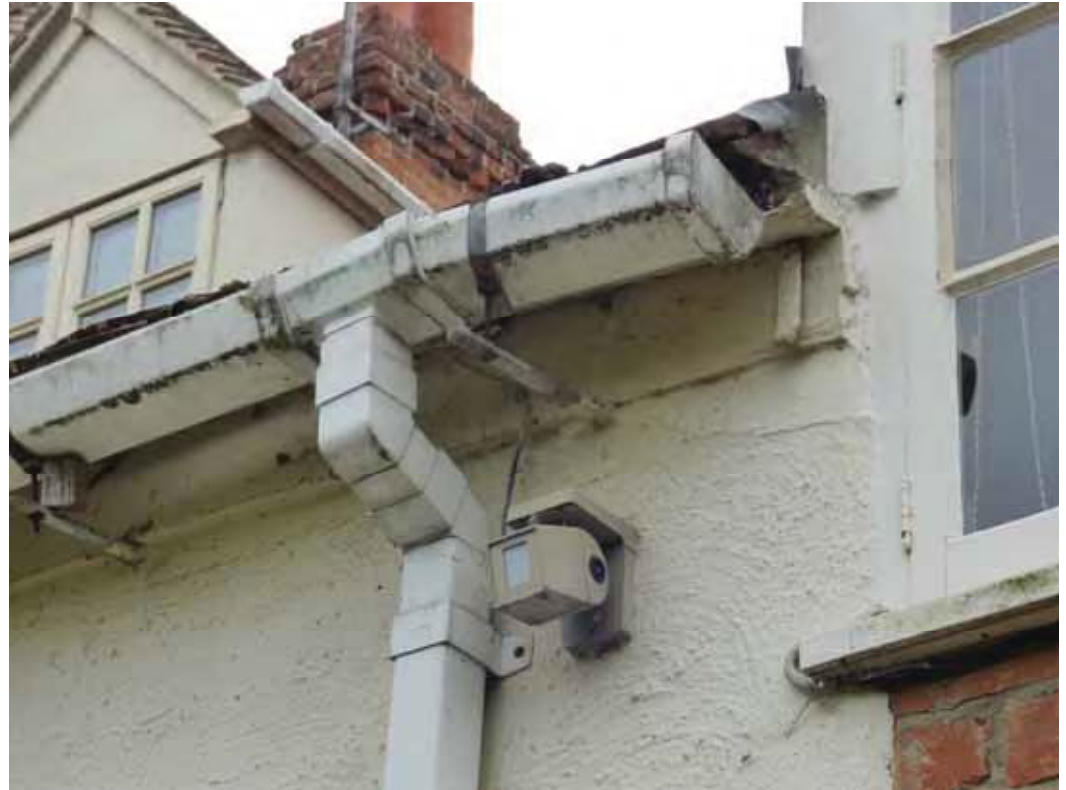
The gutters are also misaligned in areas.

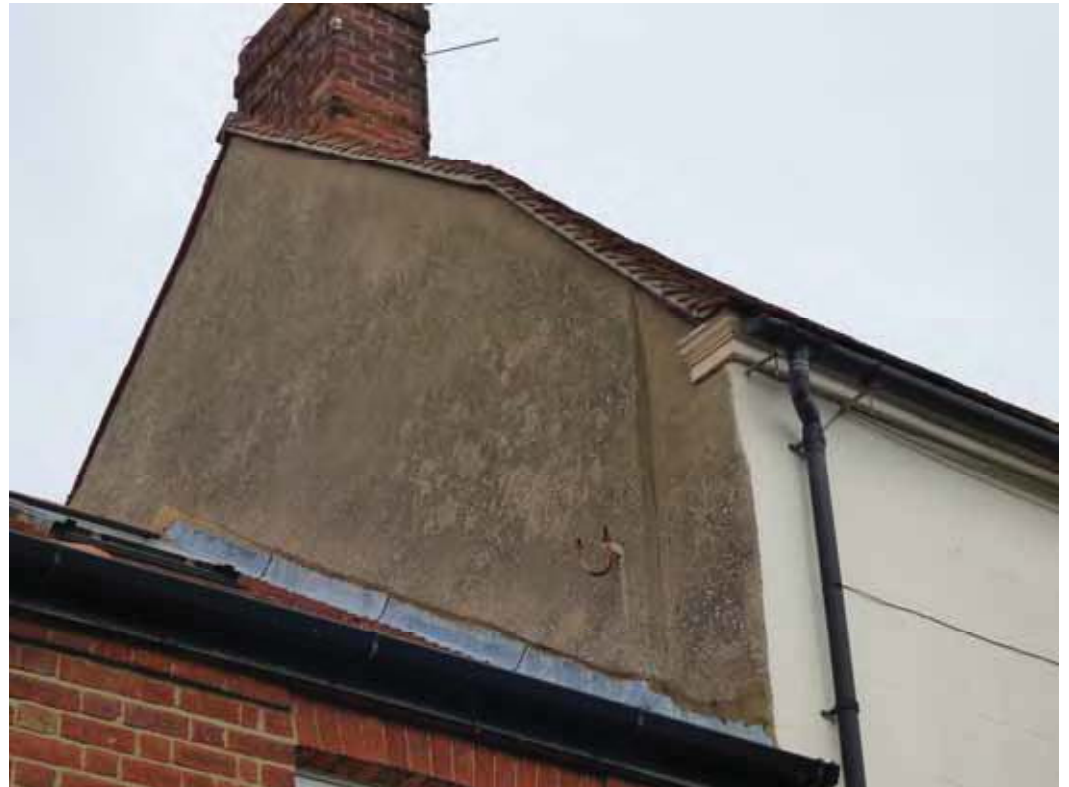
The left side rendered gable – note the vertical cracking where the façade has moved slightly from the main body of the house. This type of movement can require strapping, but there are no signs of any recent movement and no repairs are needed.

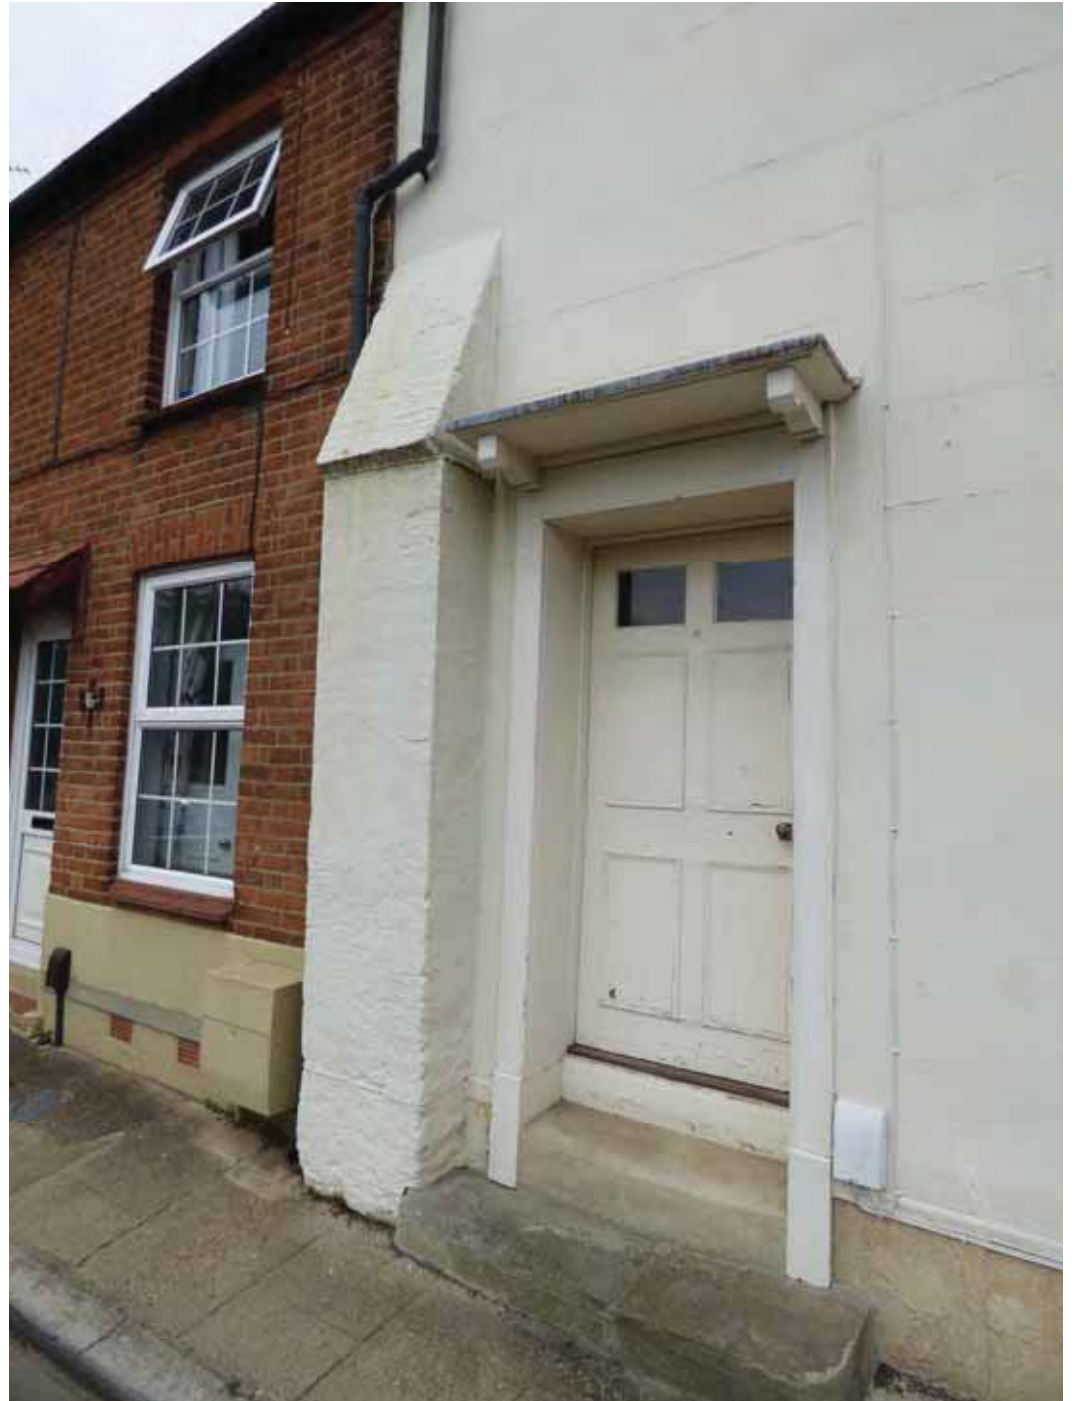
The buttress at ground floor level should help restrain movement.

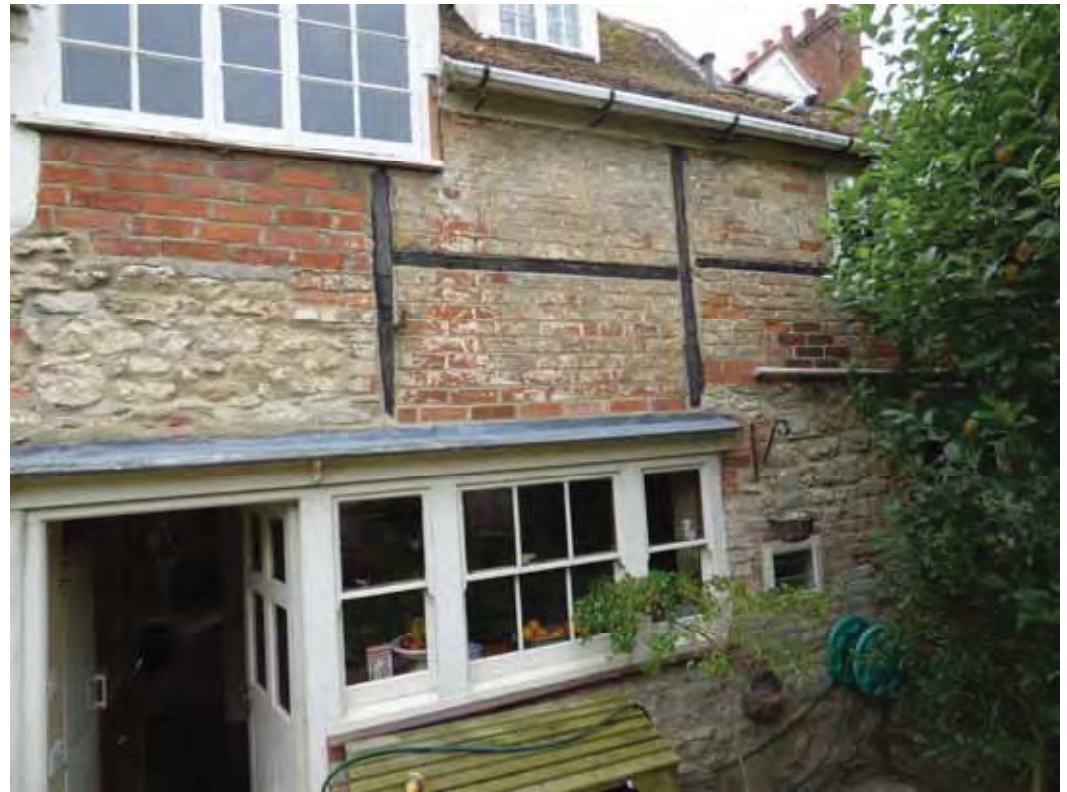
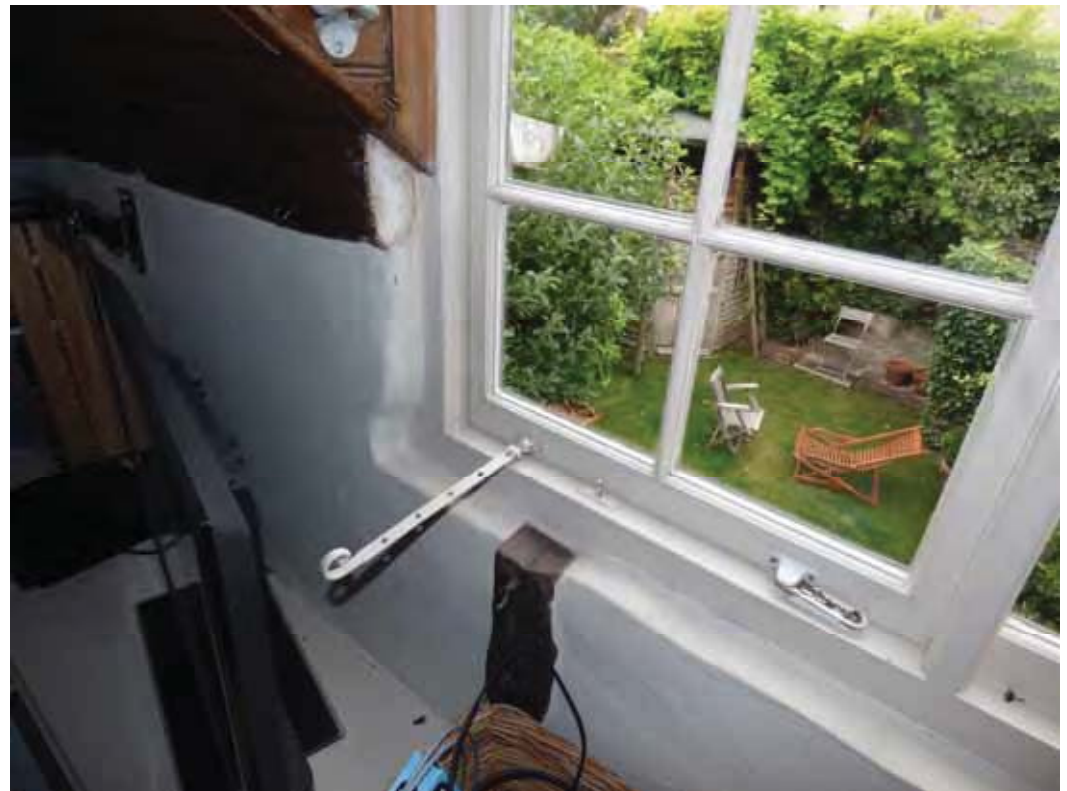
The remnants of the timber framed rear wall are visible. The lower timbers have rotted away over the years and been replaced. There are a few timbers remaining at first floor level – these have been extensively cut and weakened over the years, but this is not unduly serious

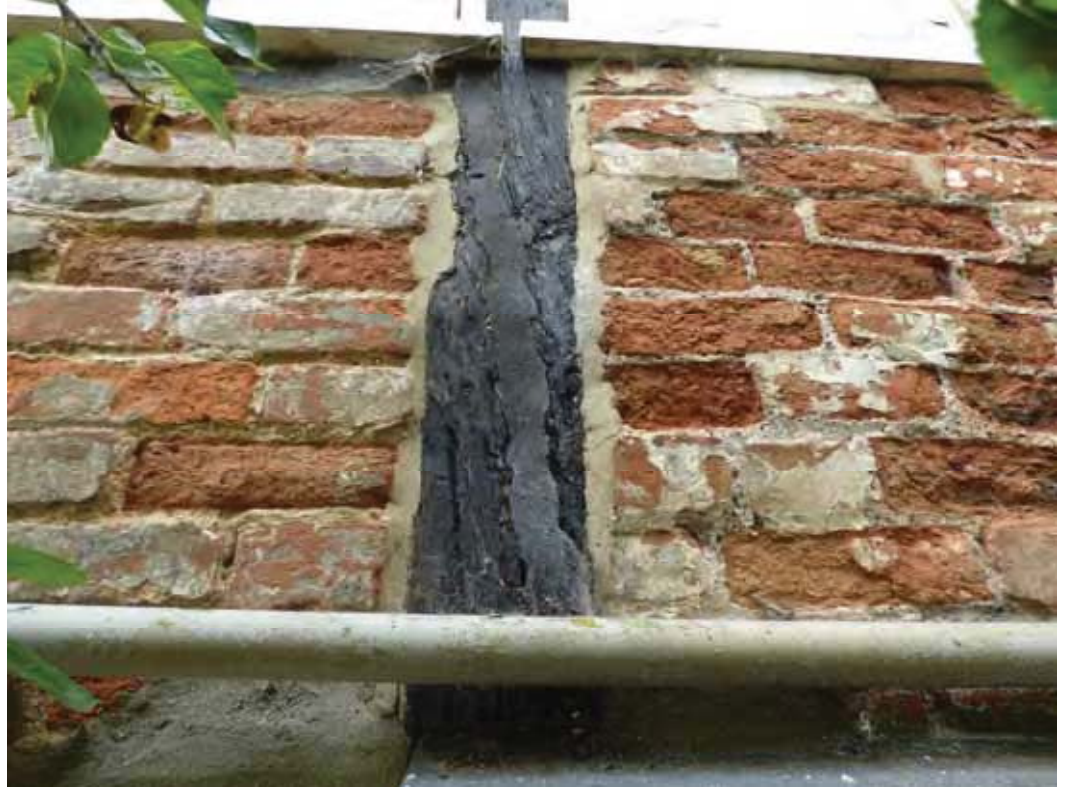
The filling of the timbers will mortar should be avoided, if possible. They are also best left unpainted.
