# Marshalls

## Chartered Surveyors

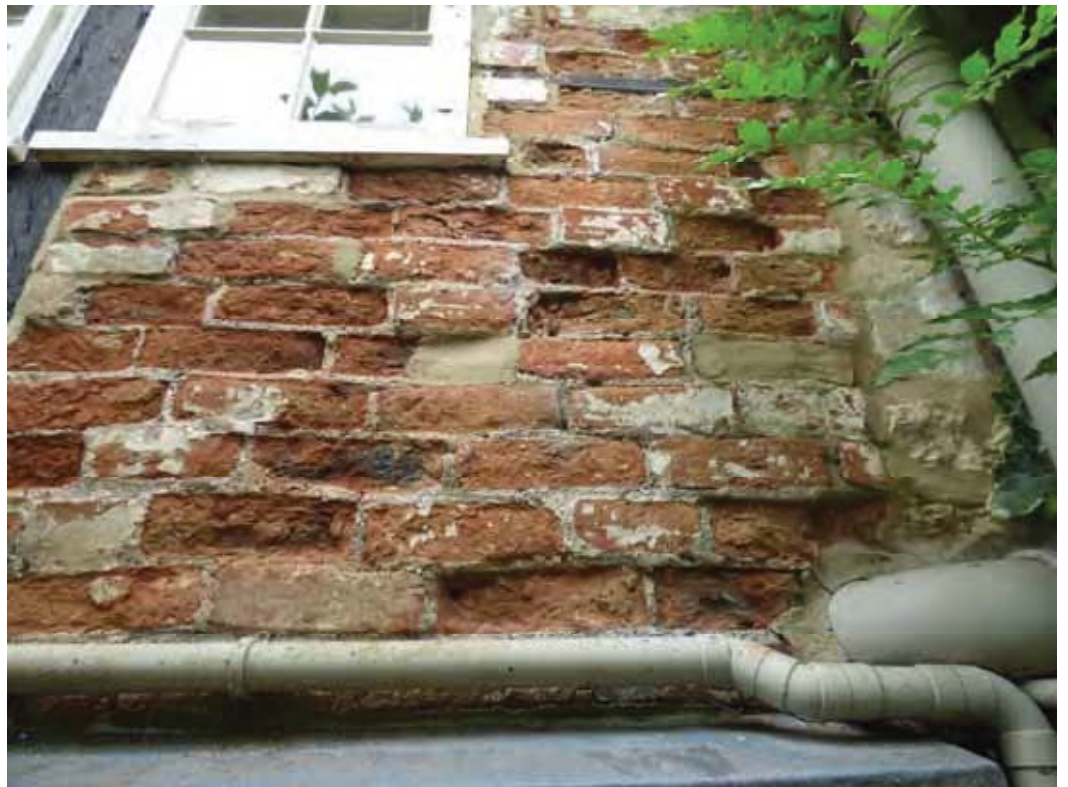
The extensive frost damage to the bricks is not ideal, but they are relatively sheltered and piecemeal replacement is not ideal. You could consider internal linings when renovation works are being undertaken.

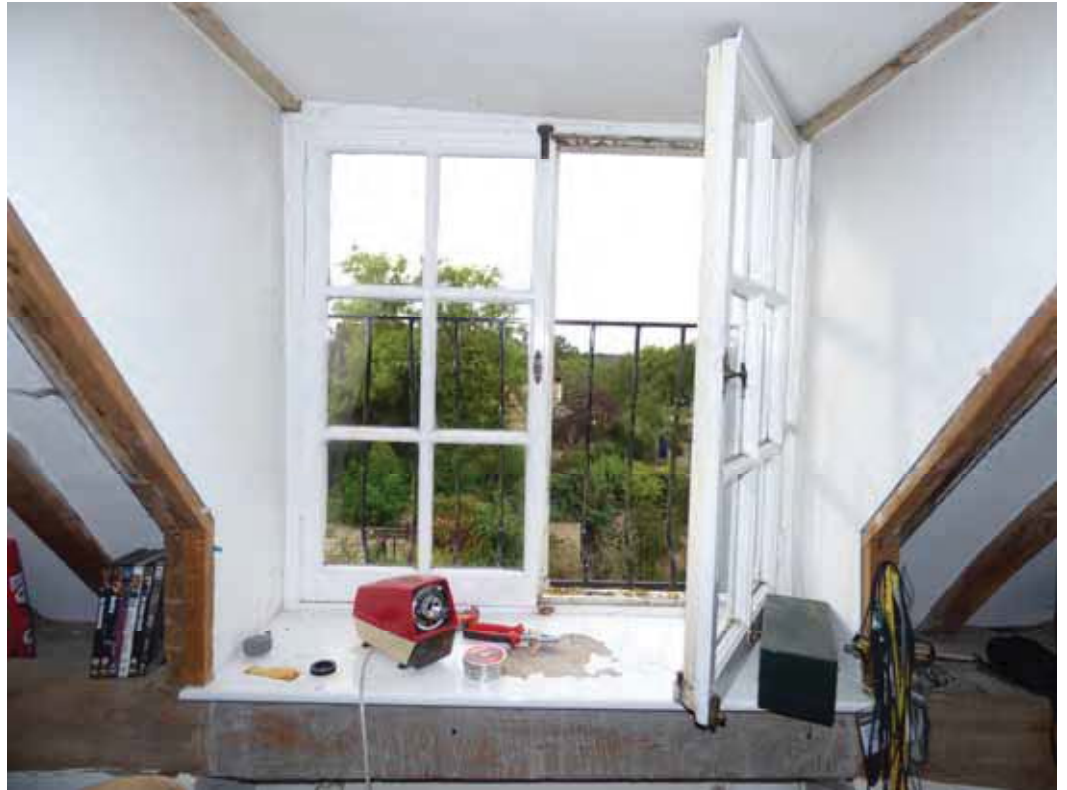
The front frames to the dormers are difficult to access and they have not been maintained.

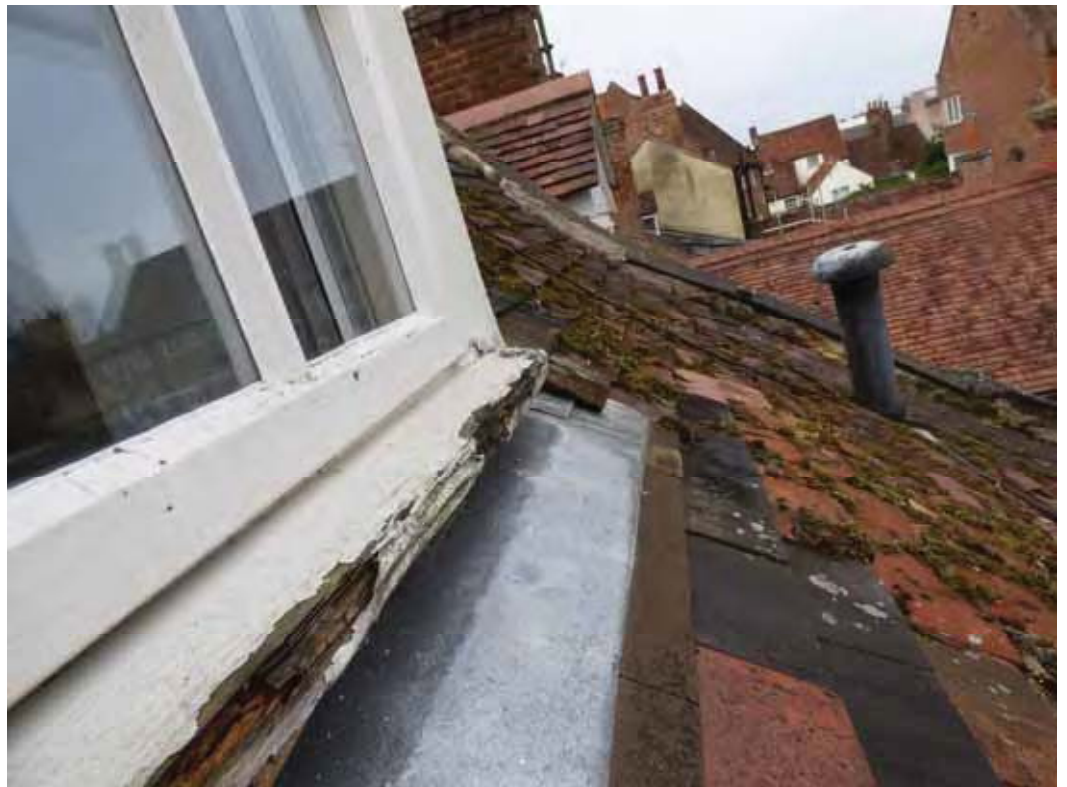
There is considerable decay.

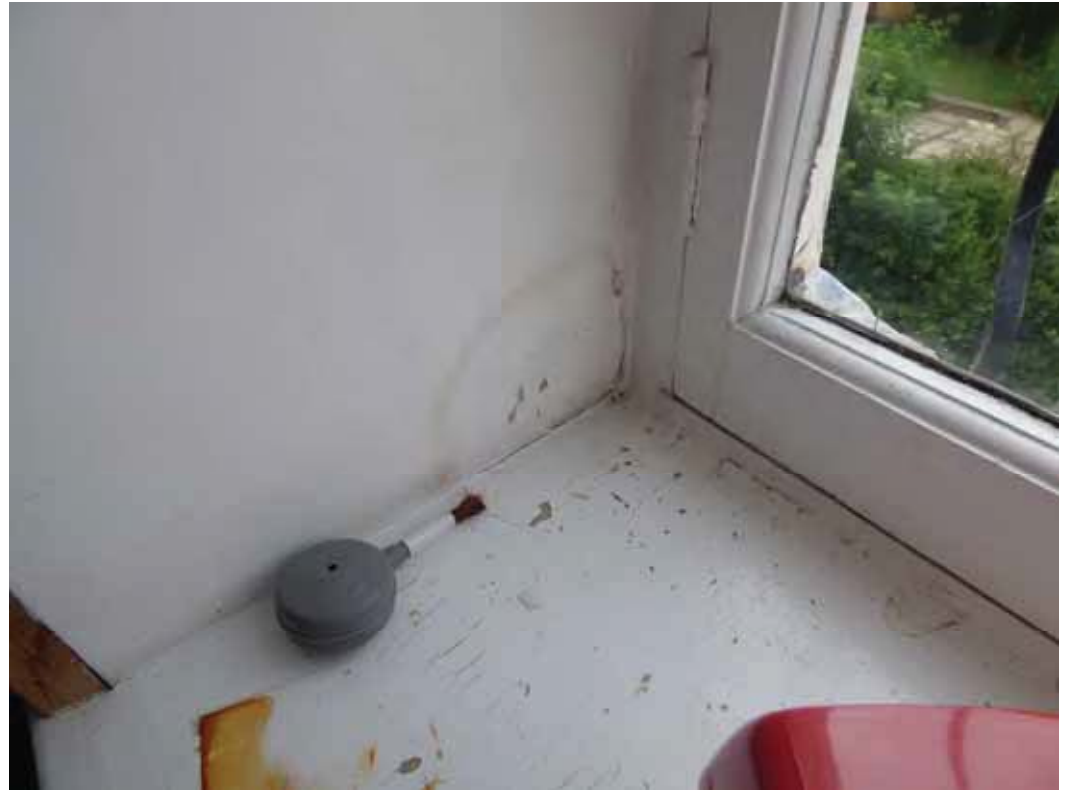
Repairs will be needed to minimise further problems and limit damp penetration.

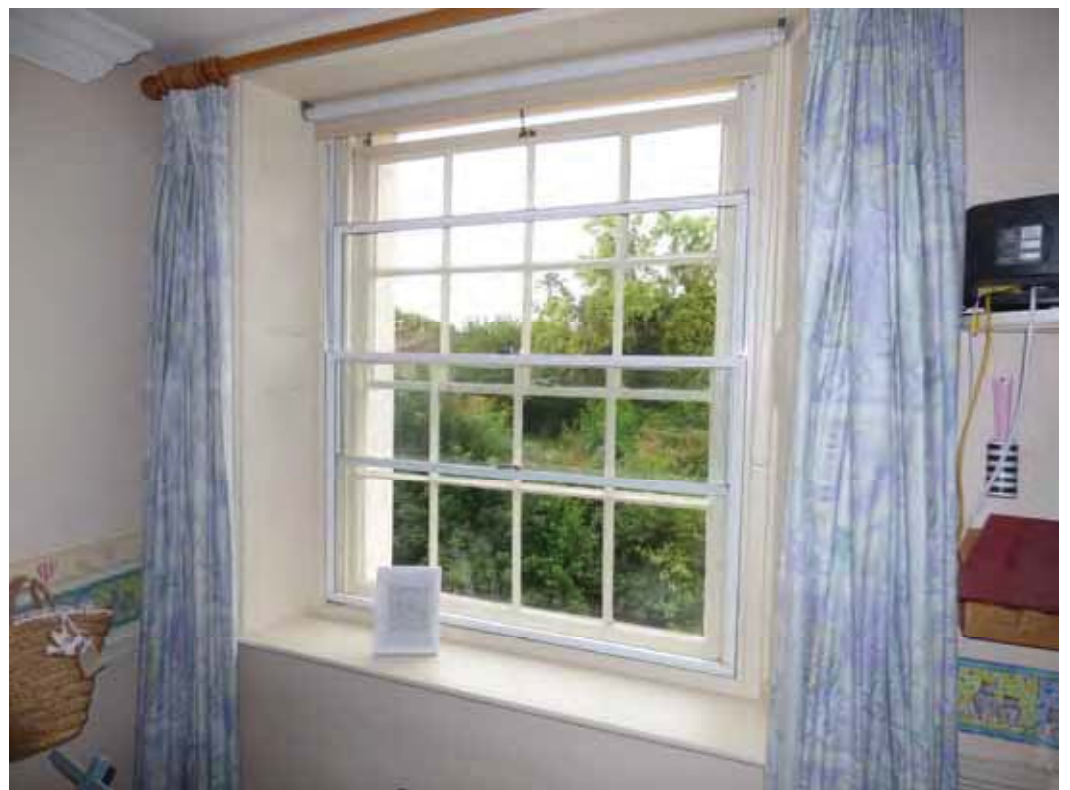
The house retains many older sashes.

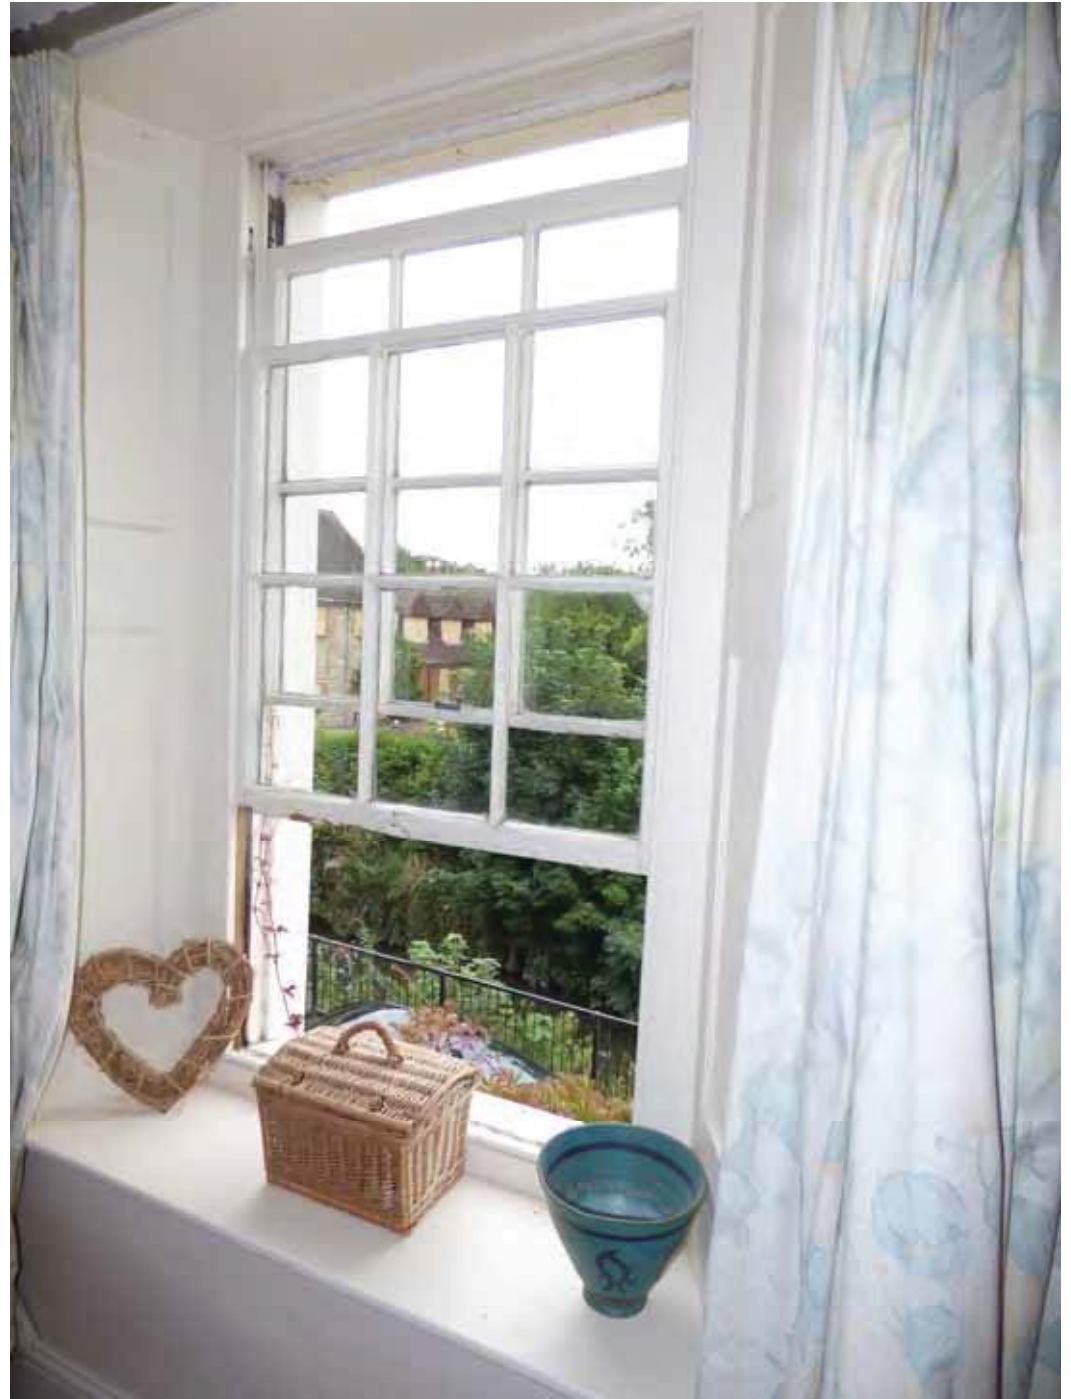
Note the rot to the lower sash – these windows are made with good quality timber, but lack of maintenance has allowed some decay, which will need repair.

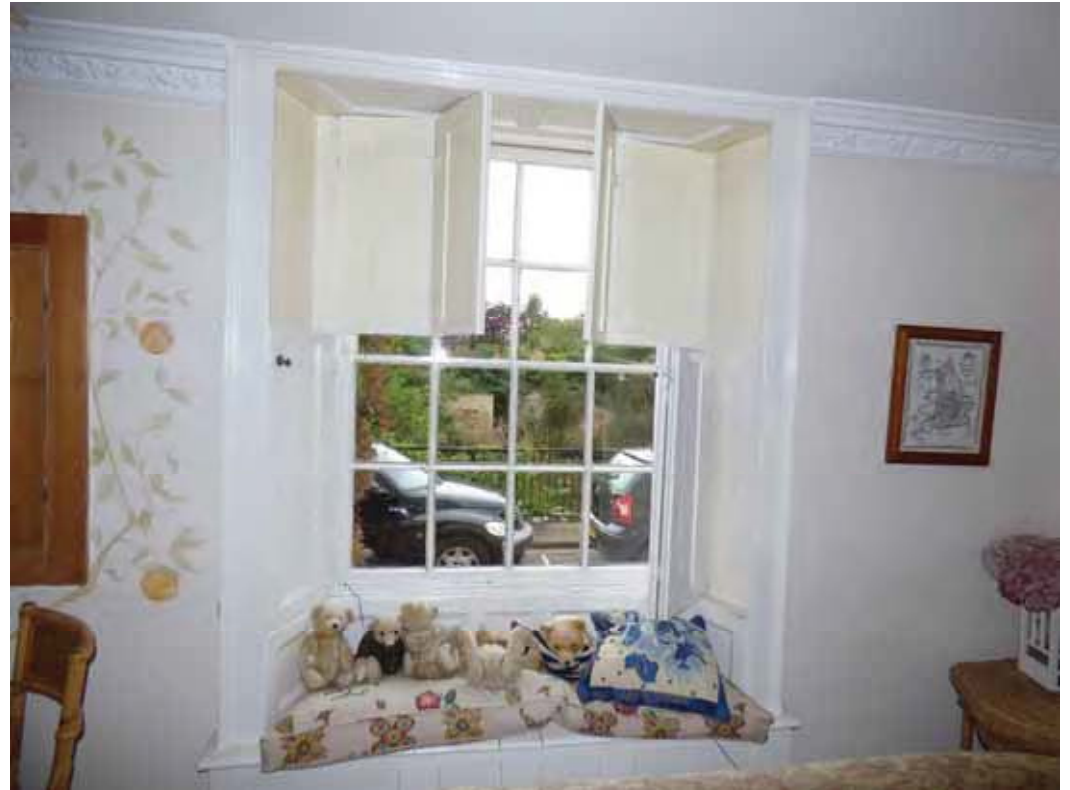
Some frames retain shutters.

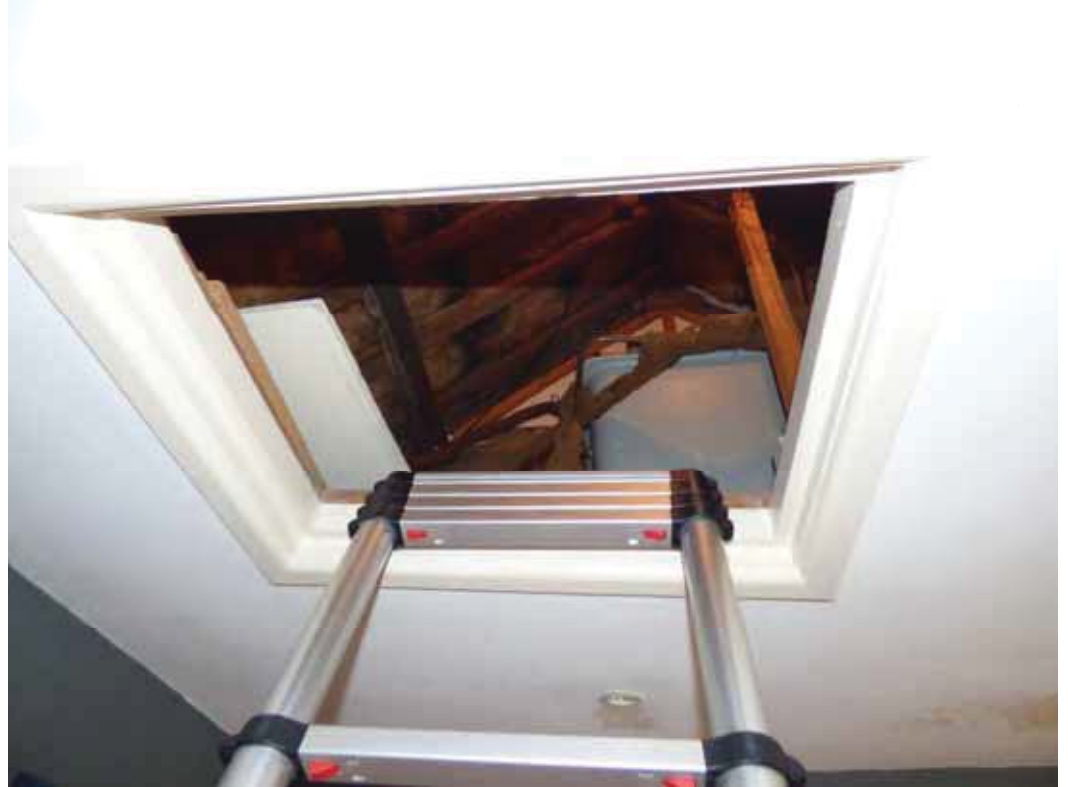
The access hatch into the main roof void.

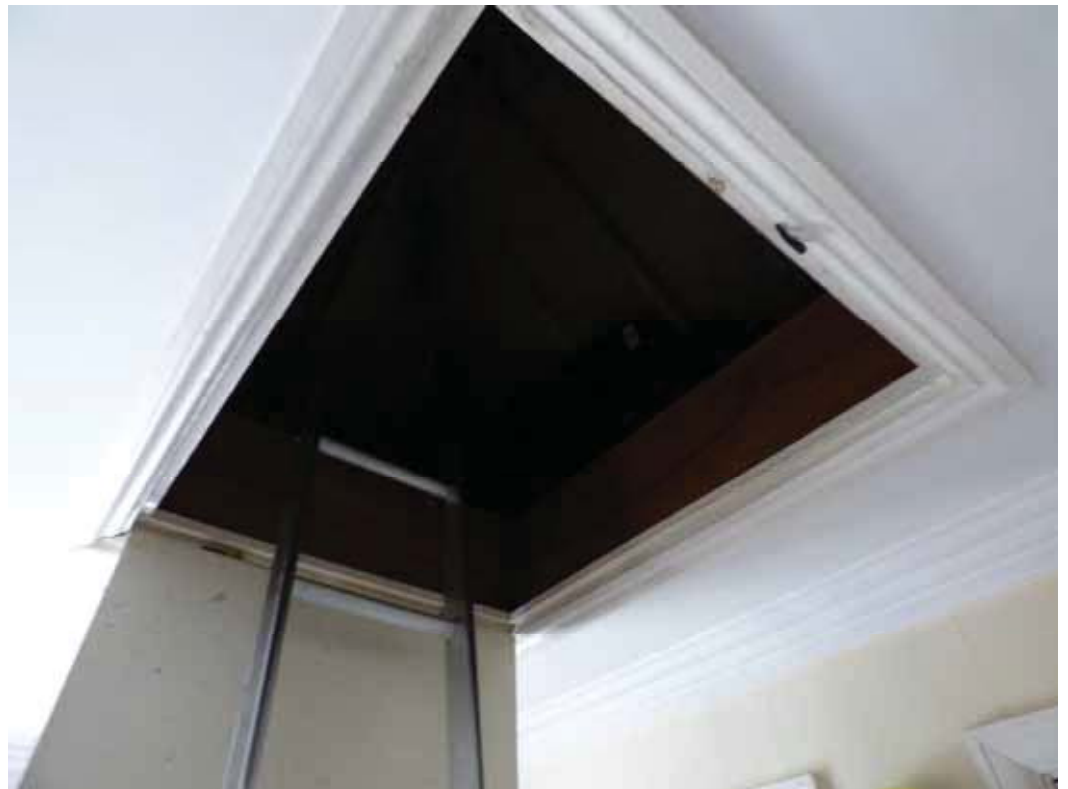
The hatch into the extension roof – there is a light and loft ladder (although this is broken).

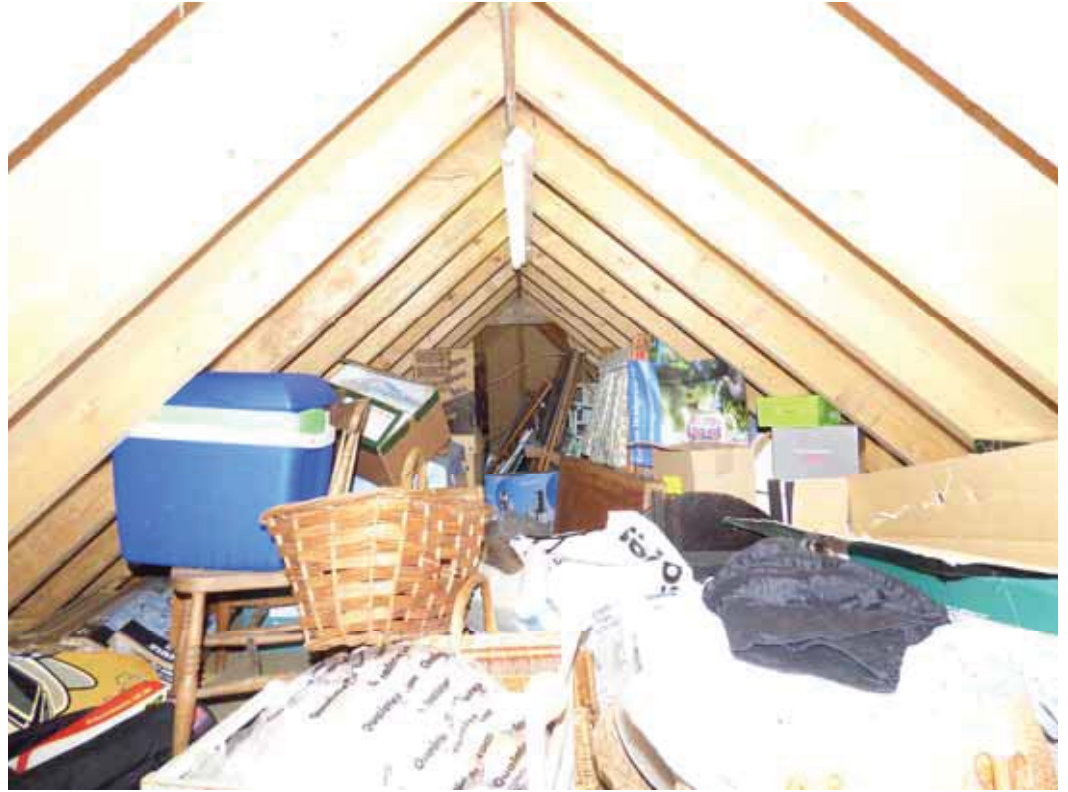
View to the front – the loft provides good storage, but should not be overloaded.

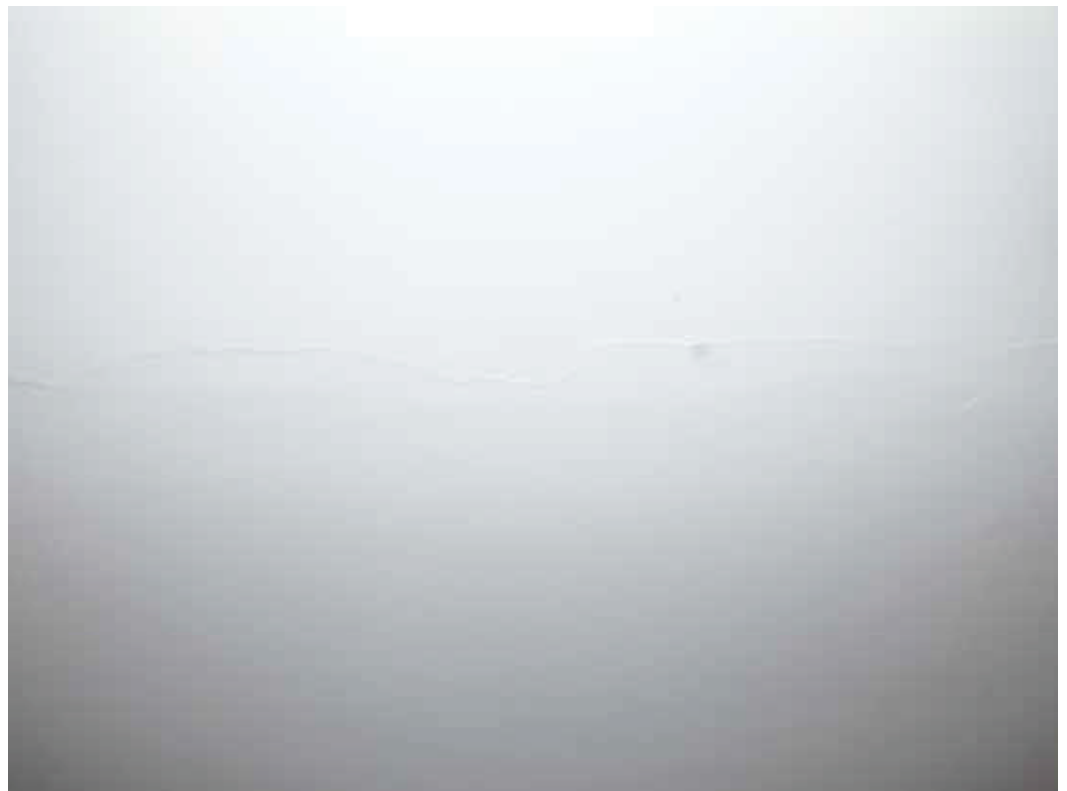
Typical shrinkage cracking to the plasterboard ceilings.

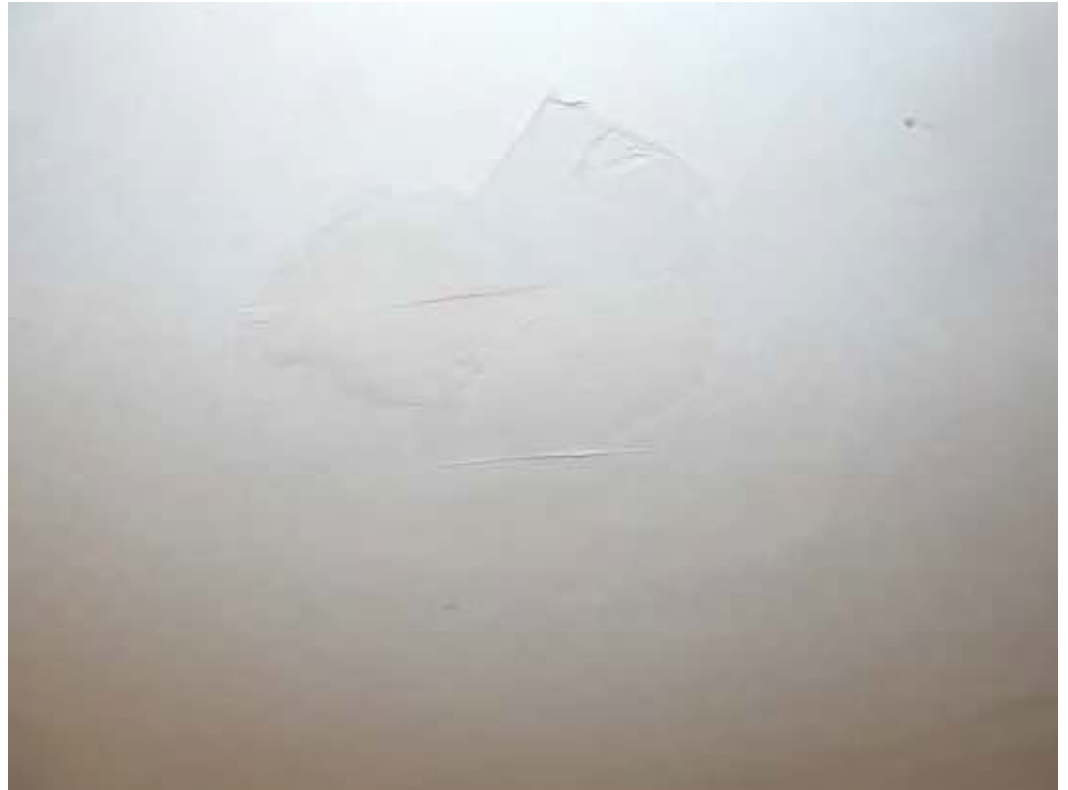
The finishes are basic in areas and would benefit from upgrading.

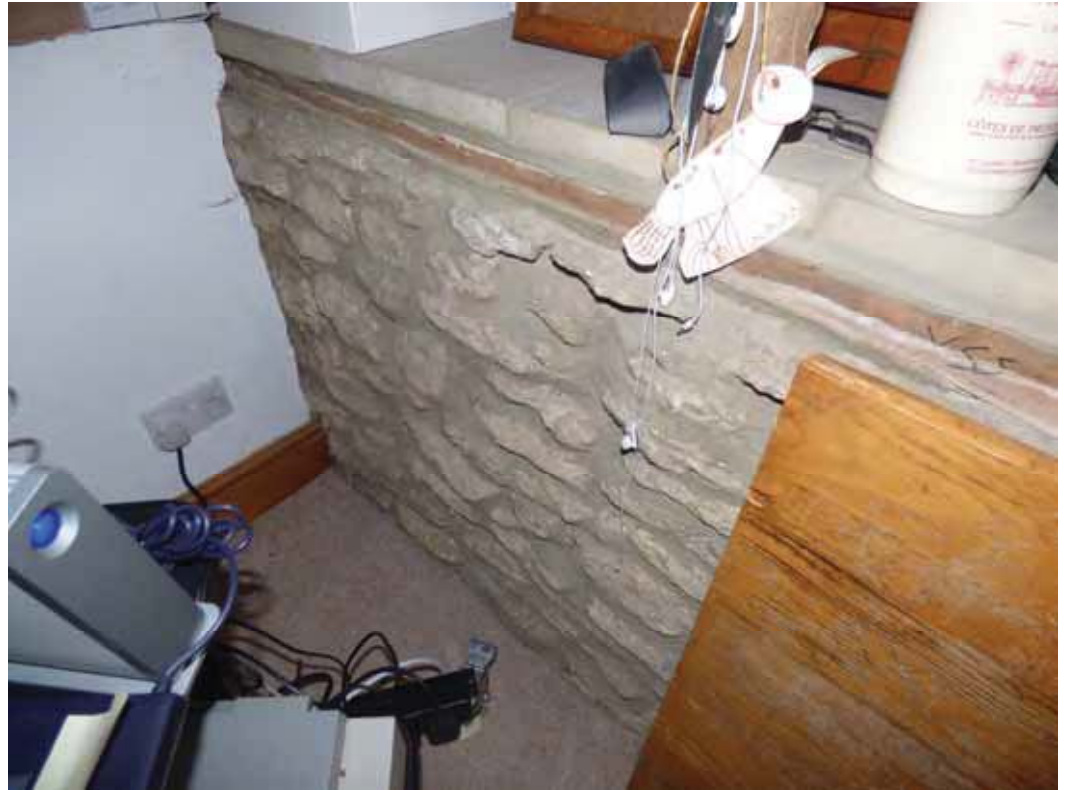
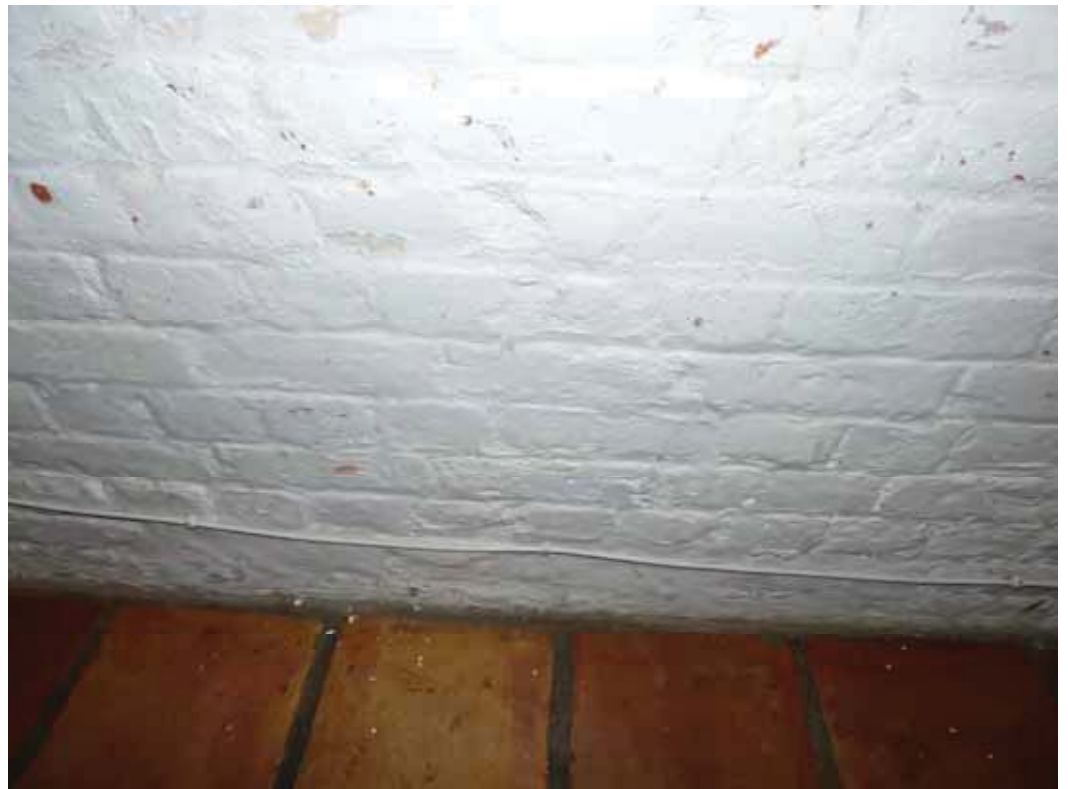
There are some exposed brick and stone walls – this is good detailing as the masonry can ‘breathe’ helping to minimise dampness.

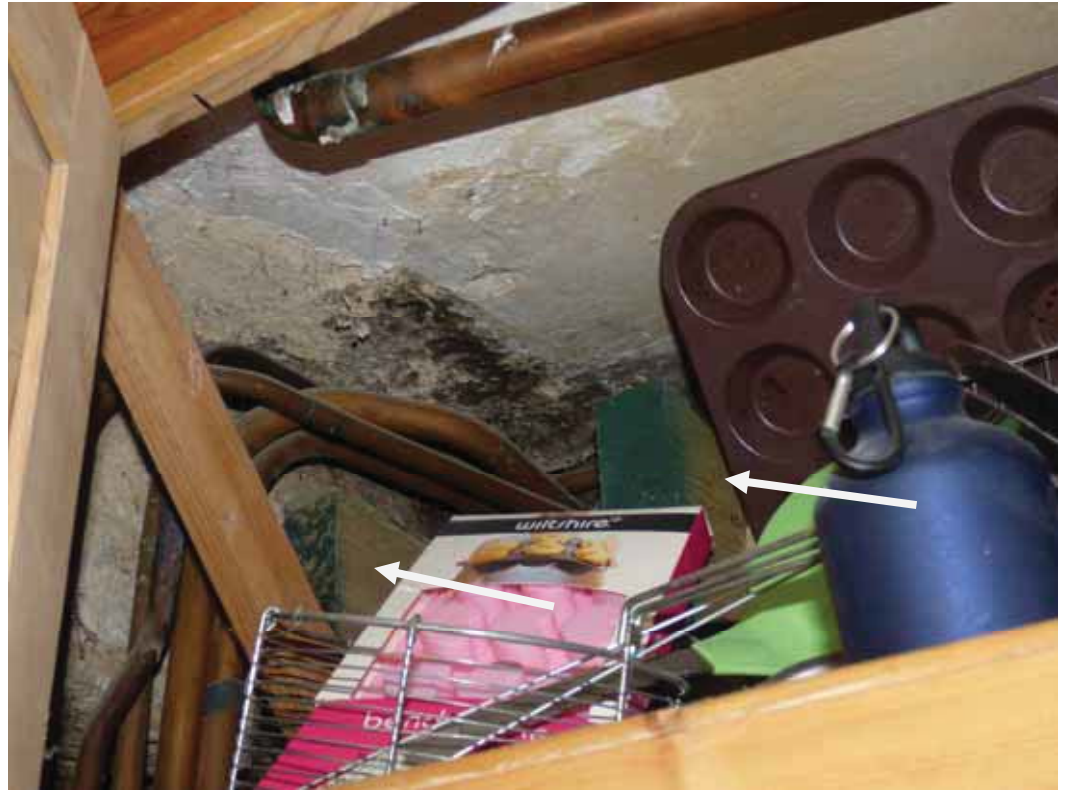
The older floors are considerably off-level, but some new joists have been installed – these support the shower room floor.

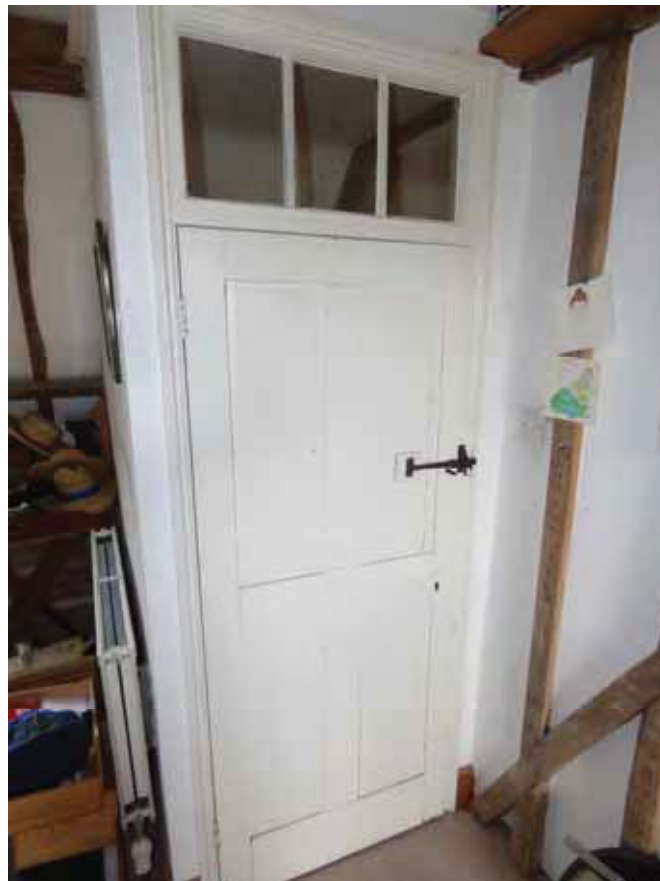
There are some good older panelled doors.

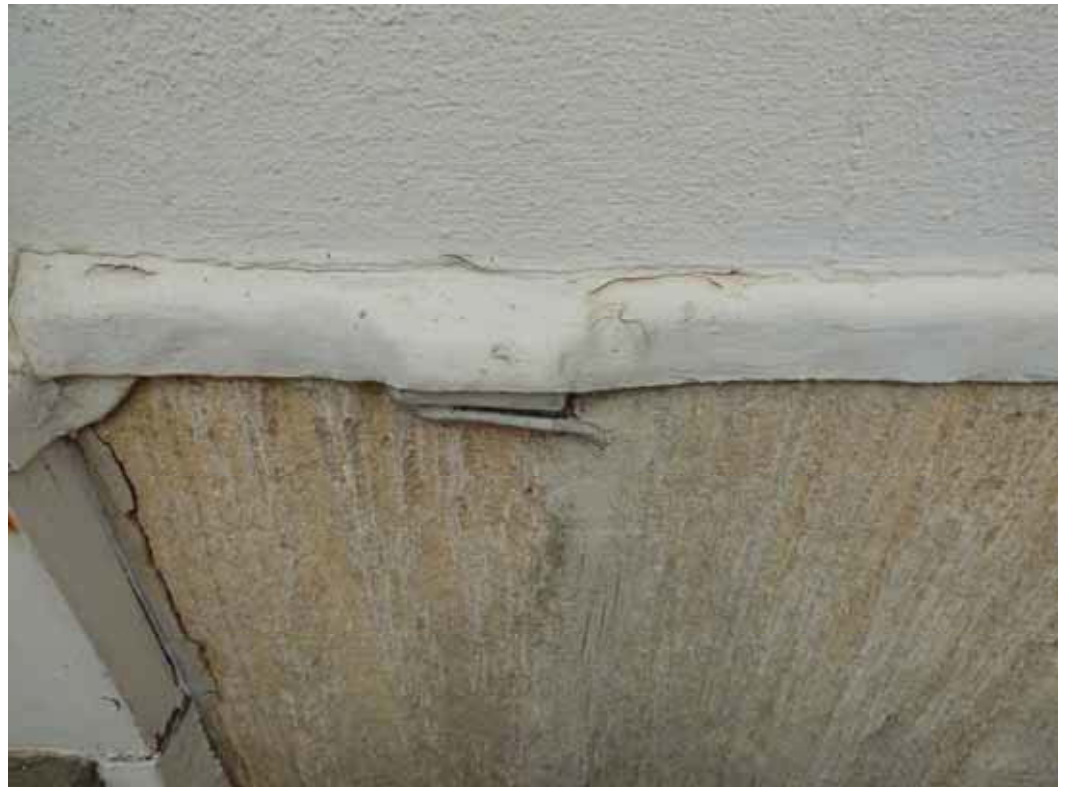
The electrolytic damp course under the lead cover flashing at the front of the house. This type of damp coursing has fallen out of favour - dampness in thick stone walls cannot be effectively treated and must be carefully managed.

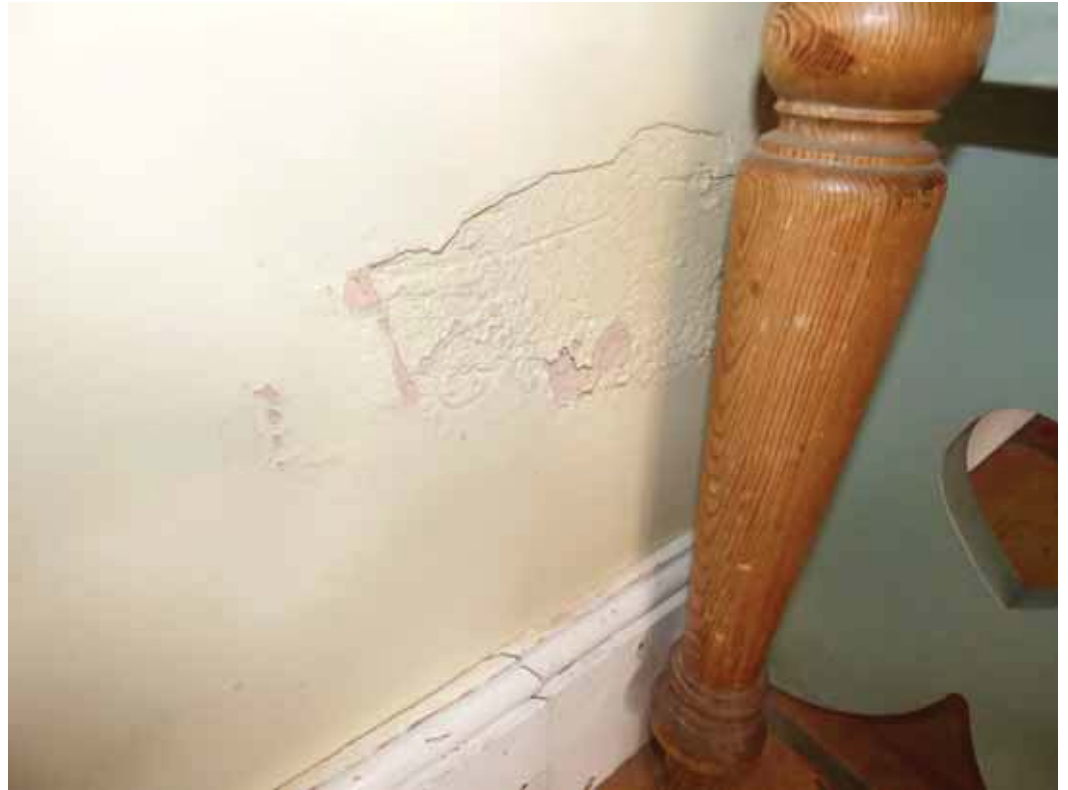
The modern gypsum plasters used in the house are not ideal and will inhibit the evaporation of moisture from the walls. The plaster will continue to break down over time. Any re-plastering should be undertaken with lime.

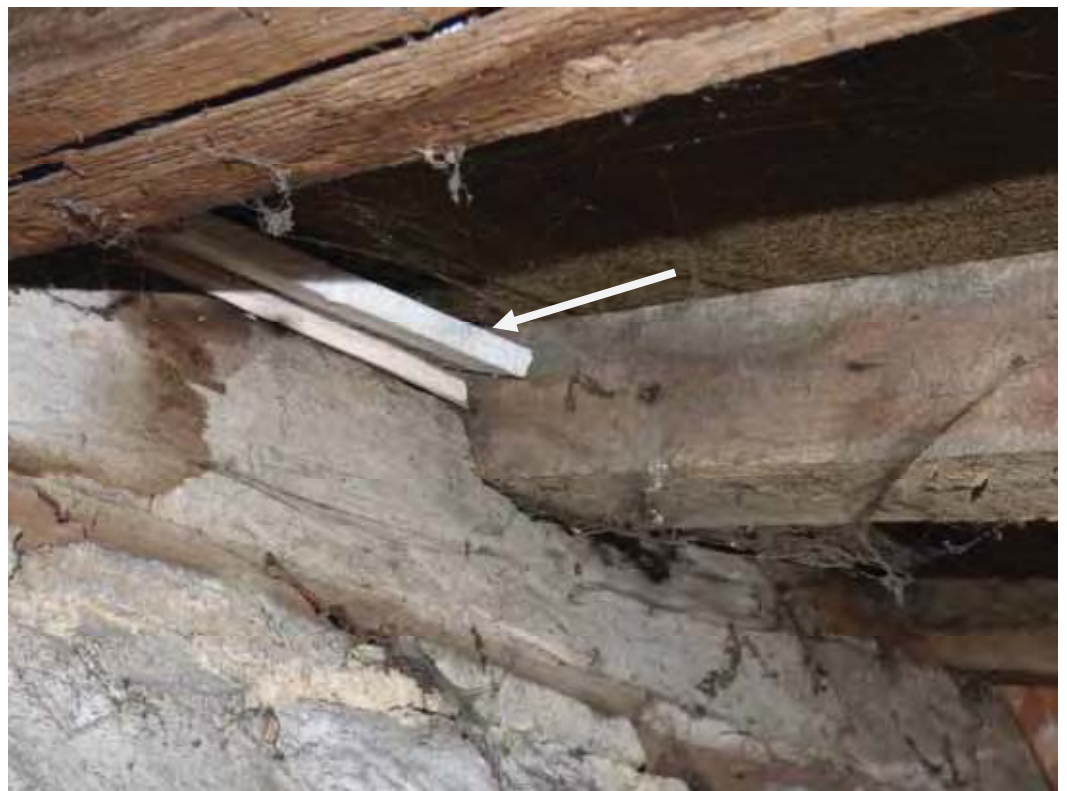
The thin polystyrene insulation to the sloping ceilings in the attic rooms. Upgrading will be difficult and disruptive.

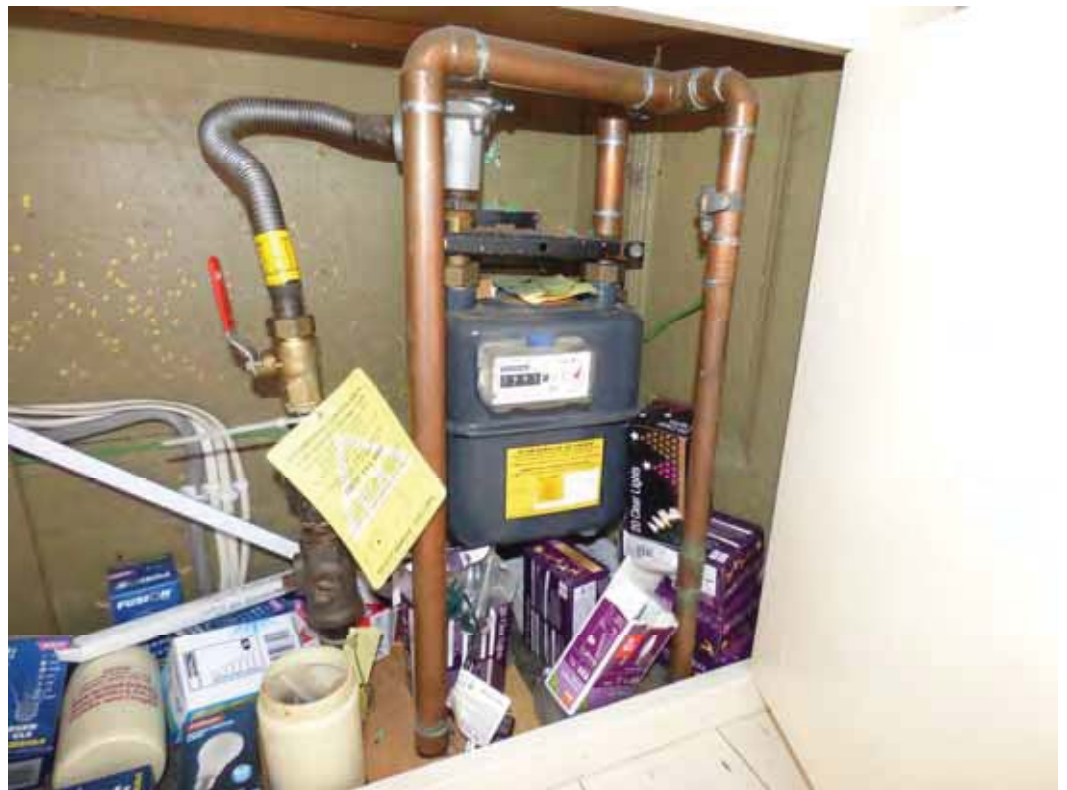
For safety, it is essential that the gas installation and all appliances should be inspected annually by a member of a 'competent person scheme' such as Gas Safe Registered engineer (<https://www.gasaferegister.co.uk/>). This is best undertaken when the central heating system is serviced.

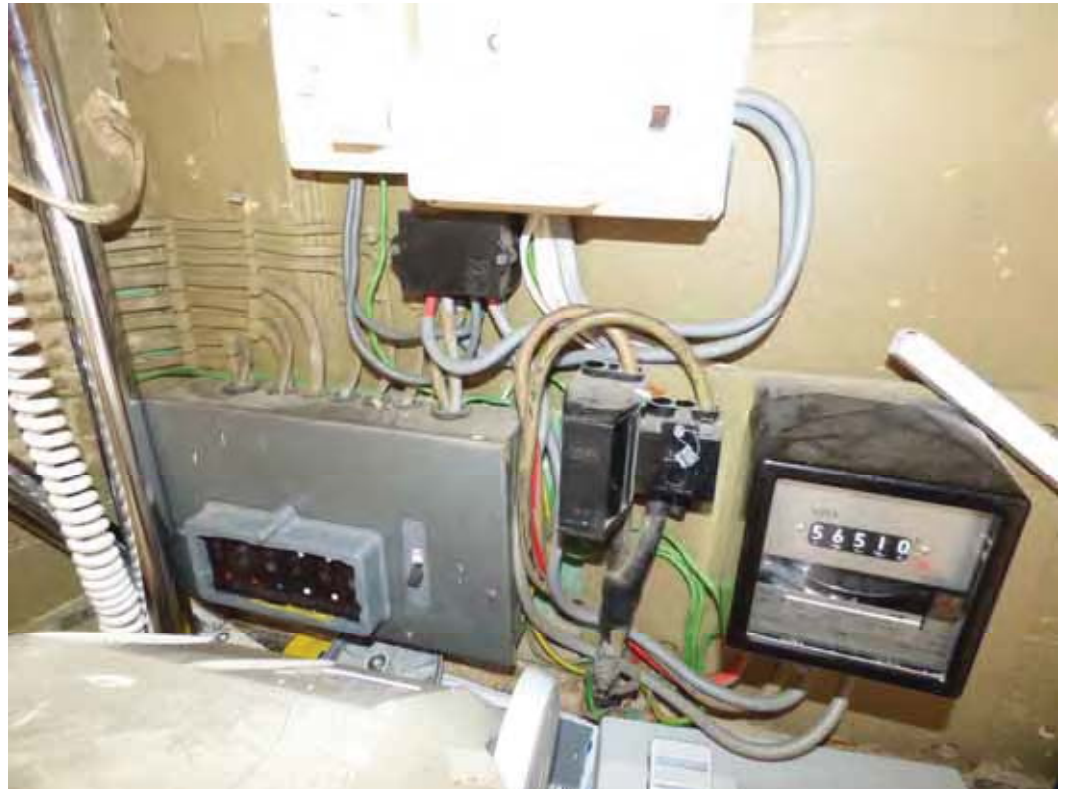
The meter and consumer units. The installation is dated and will need updating.

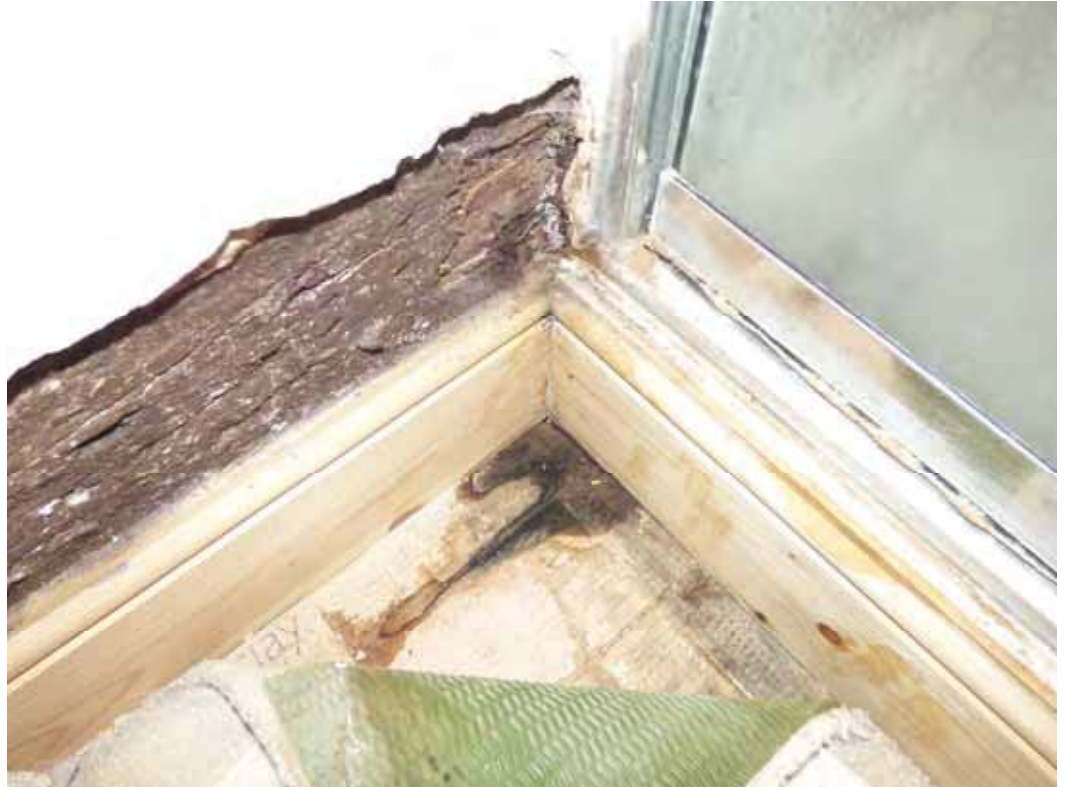
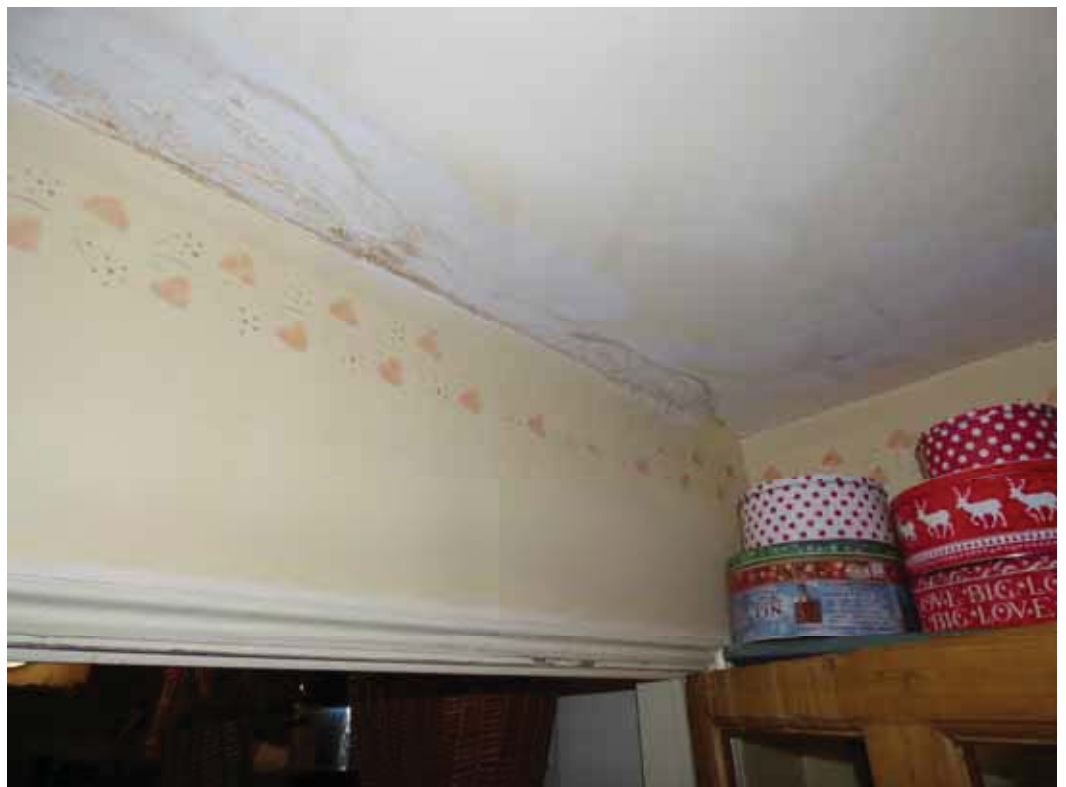
The shower room fittings.

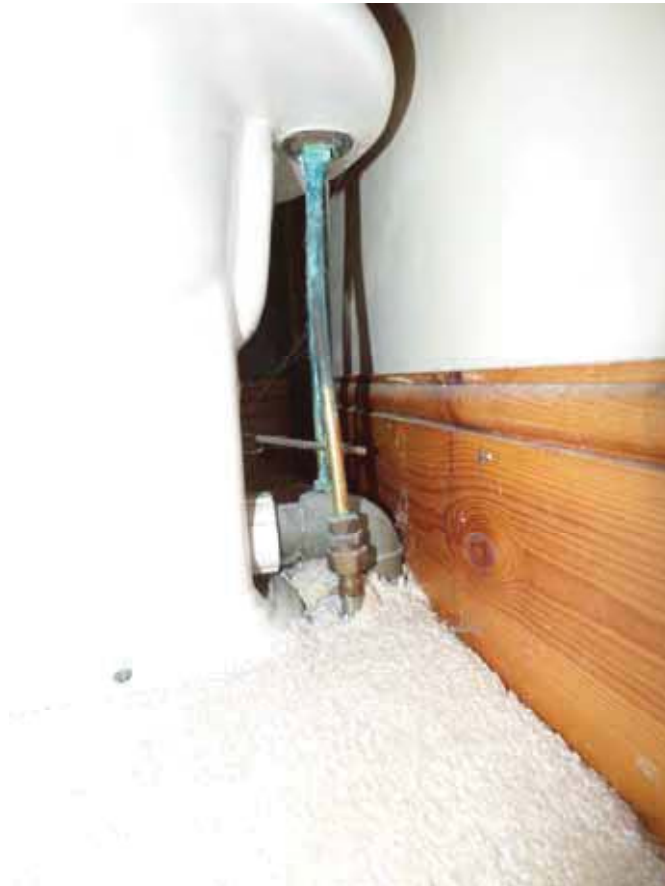
There has been some pipework leakage from the bidet – this was dry, although the unit is little used.

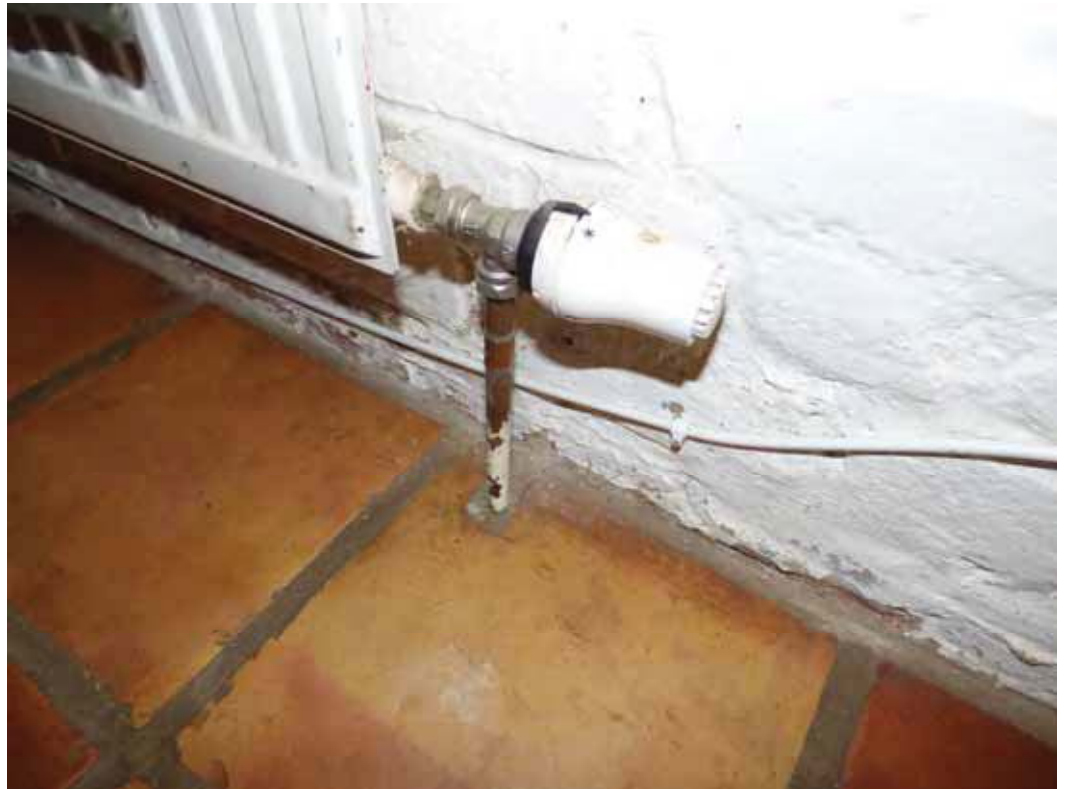
Some of the radiator service pipes are run within the floor screed and there is increased risk of pipe corrosion and associated disturbance from leakages.

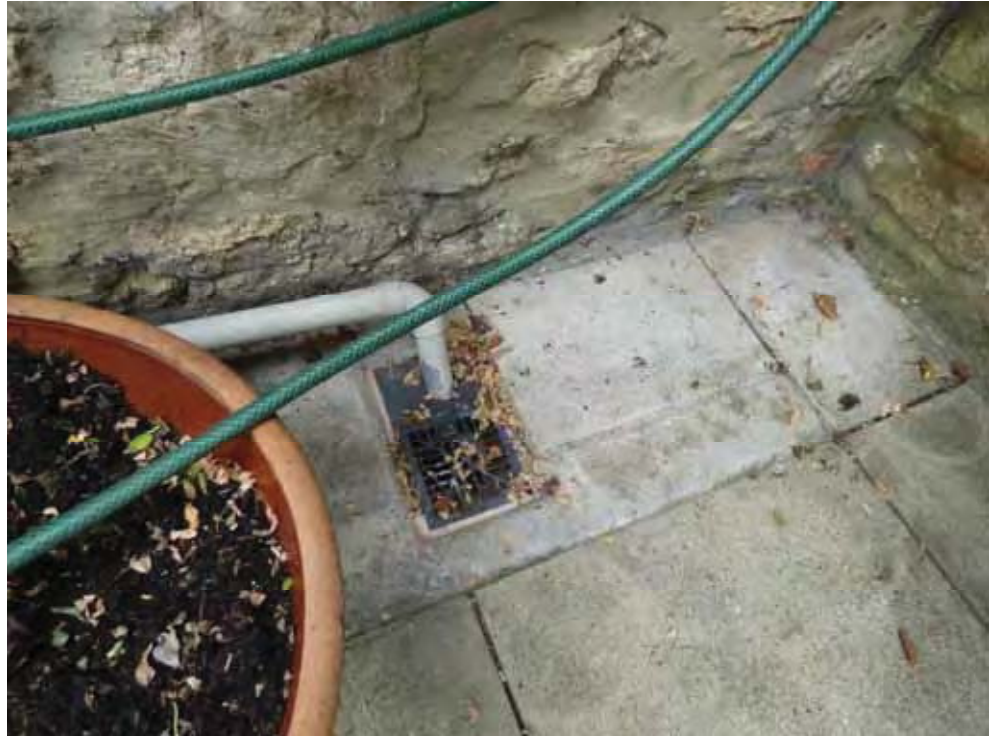
The kitchen gully is satisfactory.
